Baker Creek Improvement Project

Monitoring Report to NOAA Fisheries

Year 1 Project Summary

Mattole River Watershed
BLM Arcata Field Office

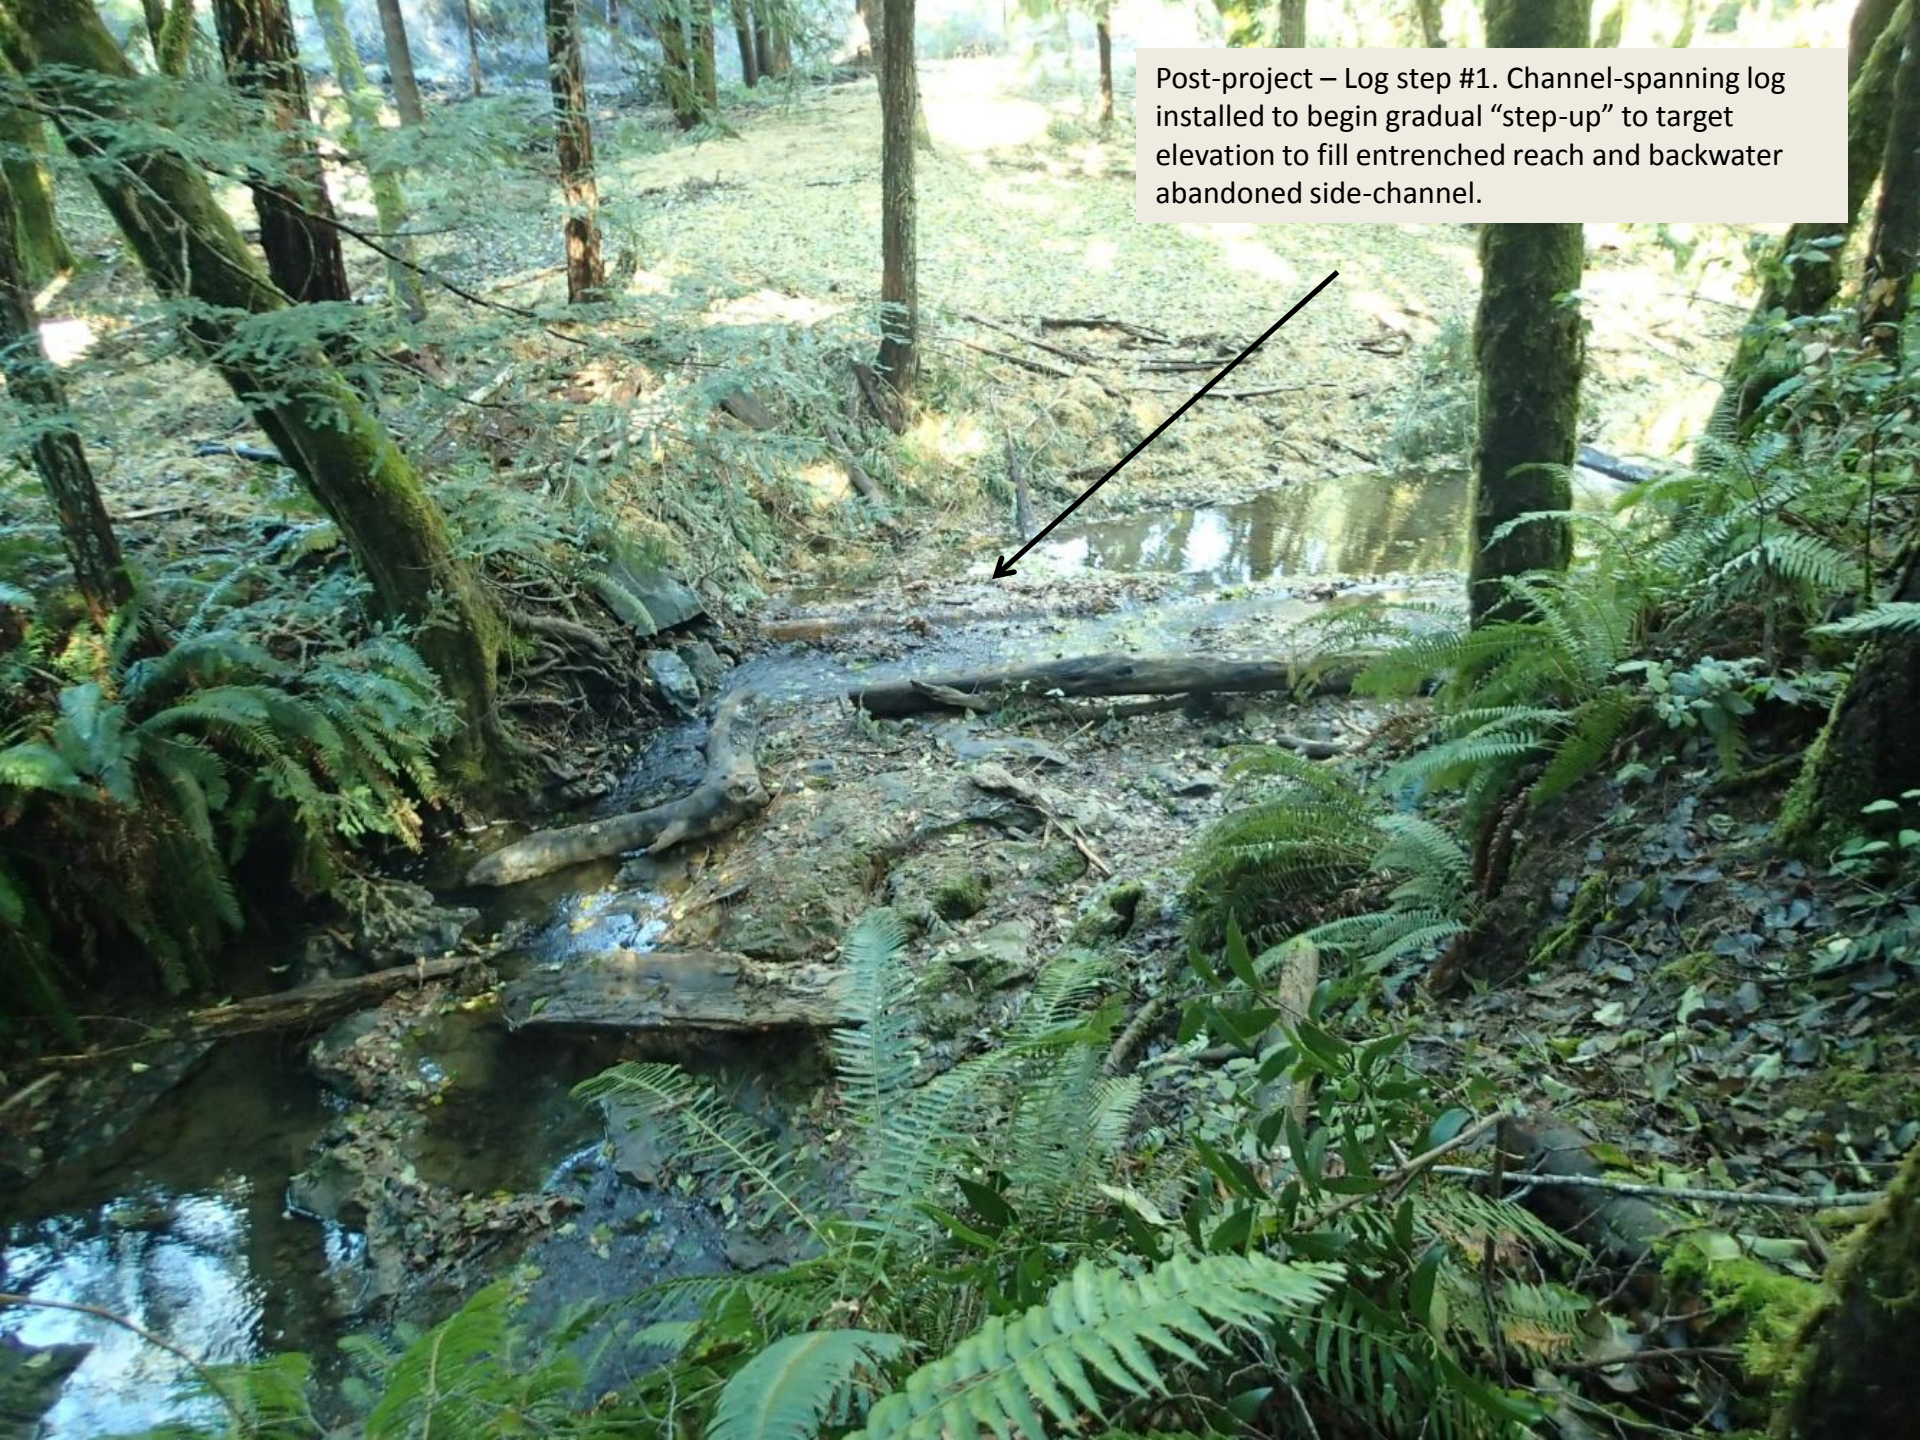
Post-project – Log step #1. Channel-spanning log installed to begin gradual “step-up” to target elevation to fill entrenched reach and backwater abandoned side-channel.

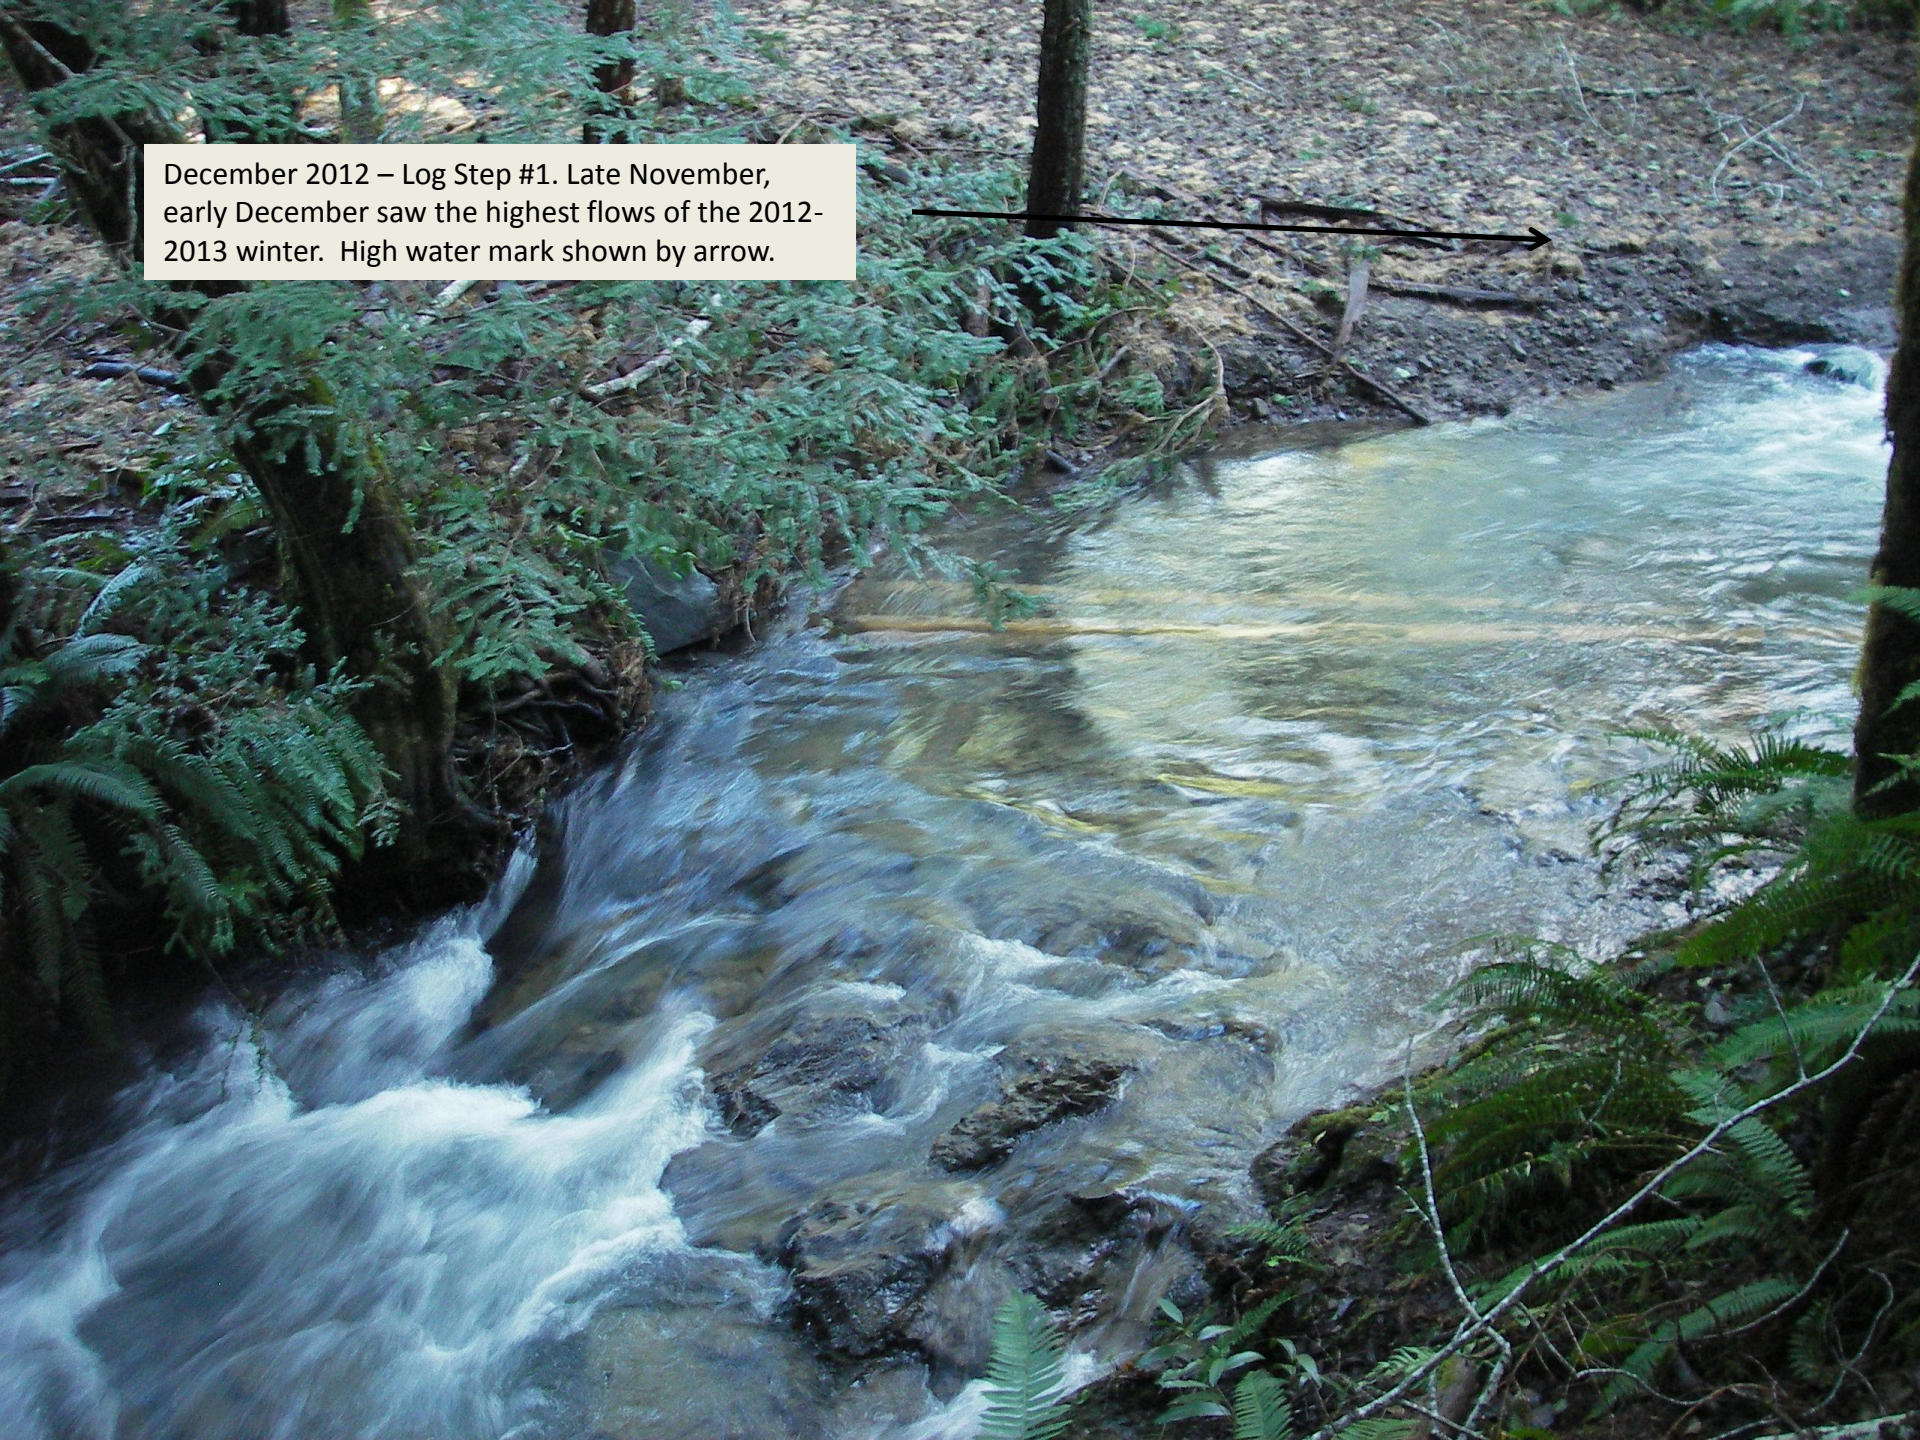
December 2012 – Log Step #1. Late November, early December saw the highest flows of the 2012-2013 winter. High water mark shown by arrow.

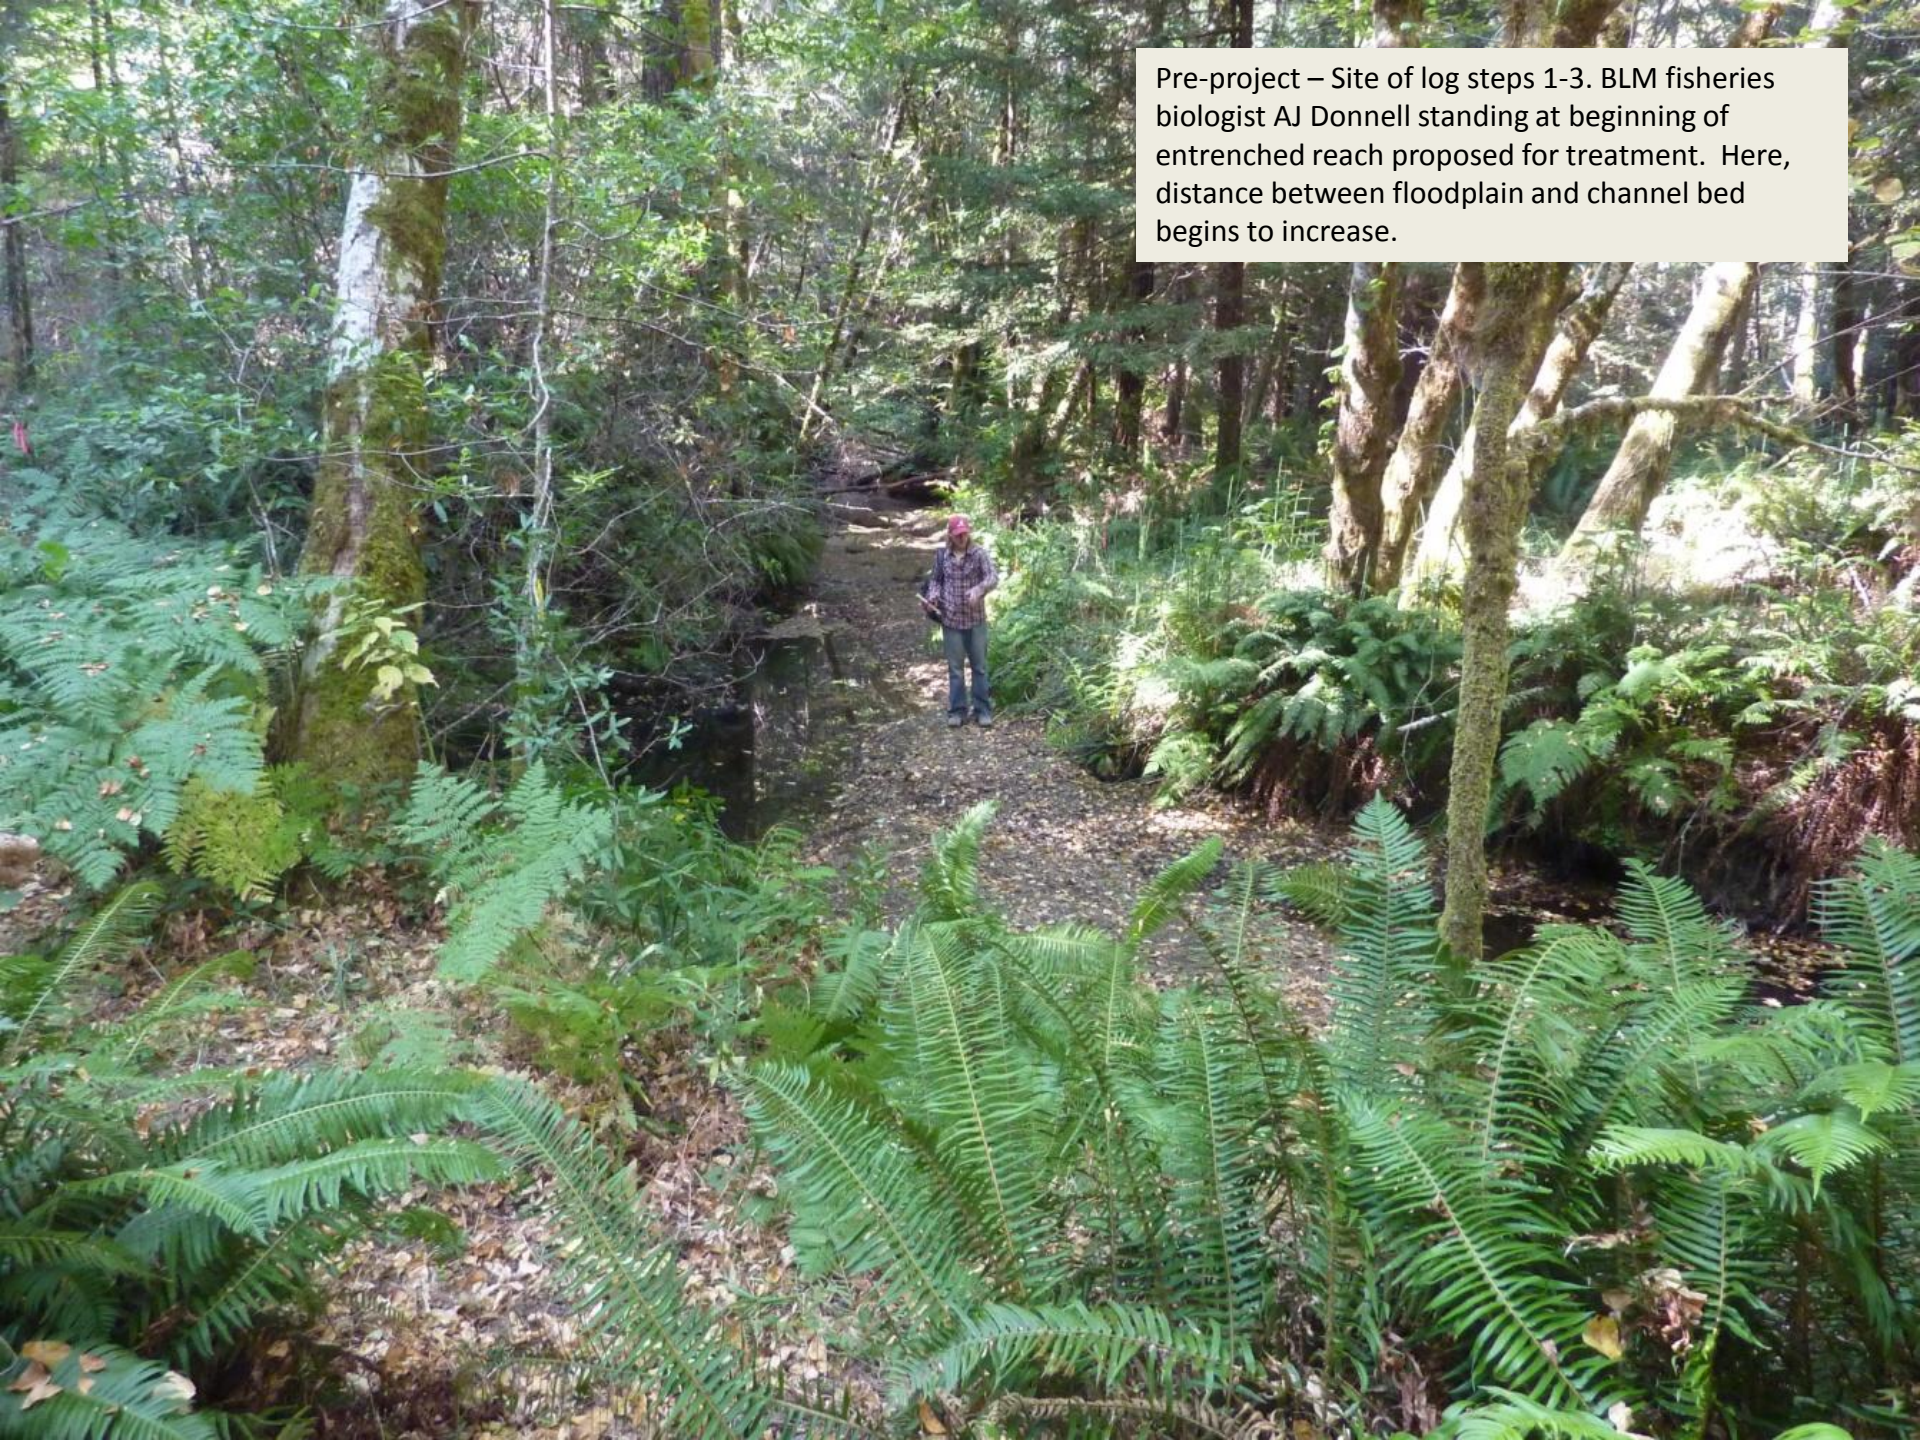
Pre-project – Site of log steps 1-3. BLM fisheries biologist AJ Donnell standing at beginning of entrenched reach proposed for treatment. Here, distance between floodplain and channel bed begins to increase.

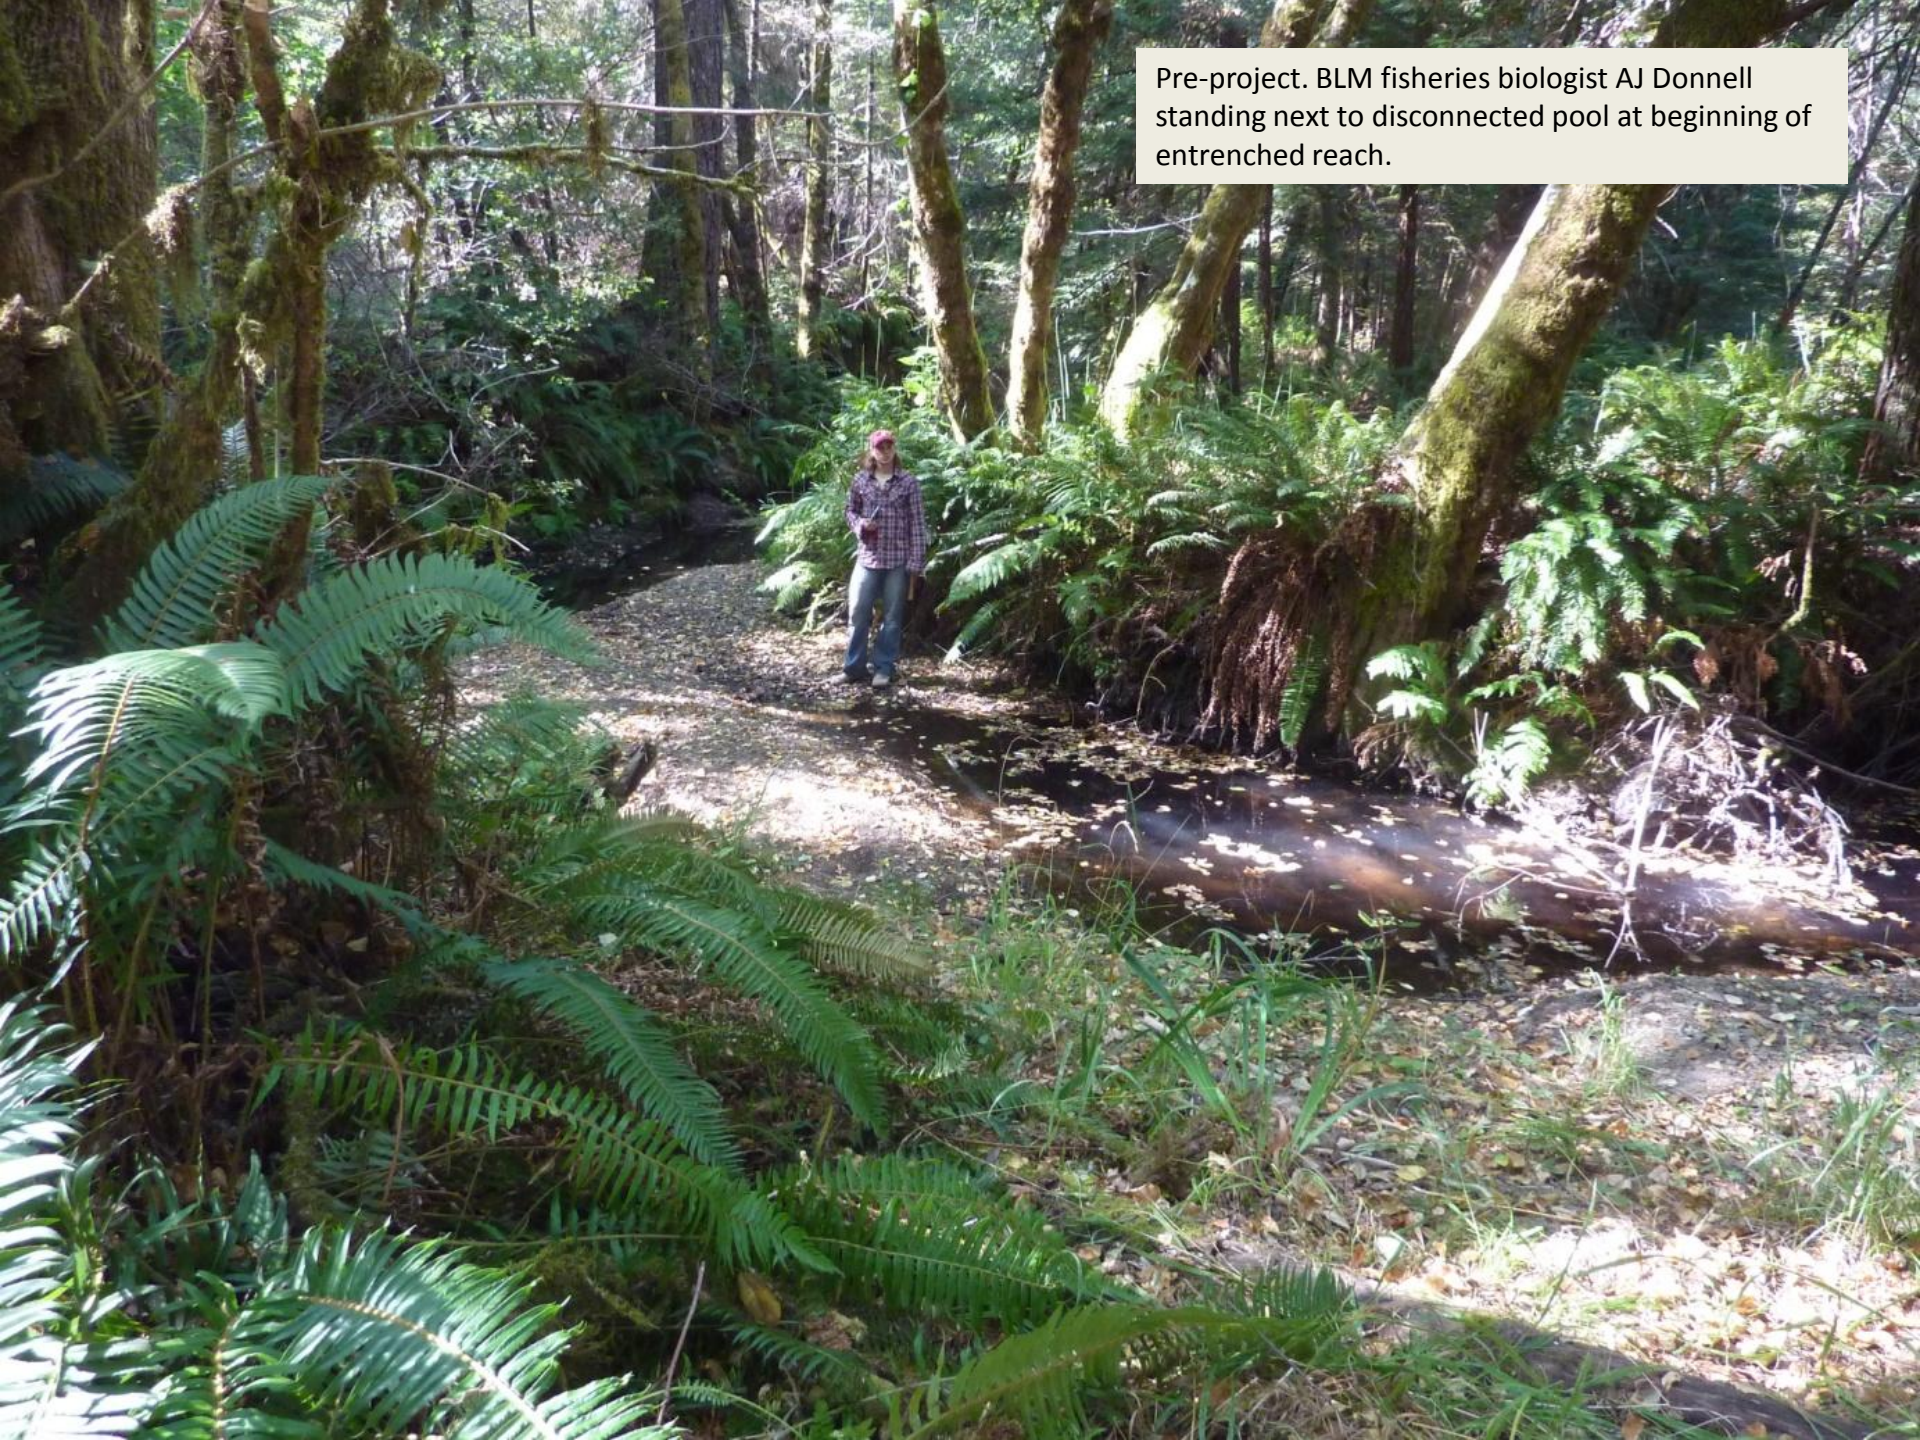
Pre-project. BLM fisheries biologist AJ Donnell standing next to disconnected pool at beginning of entrenched reach.

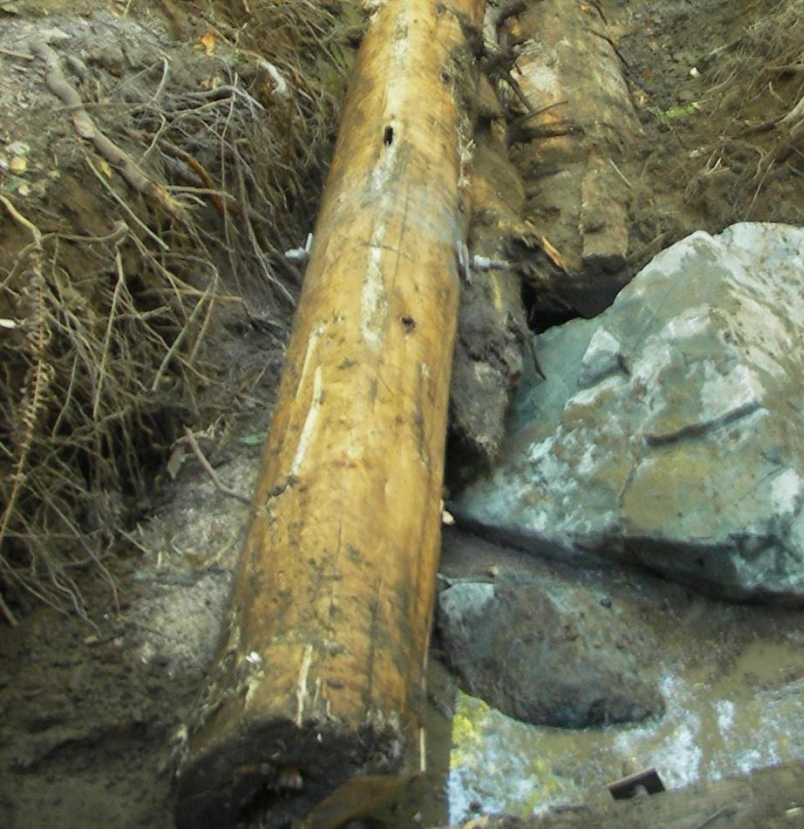
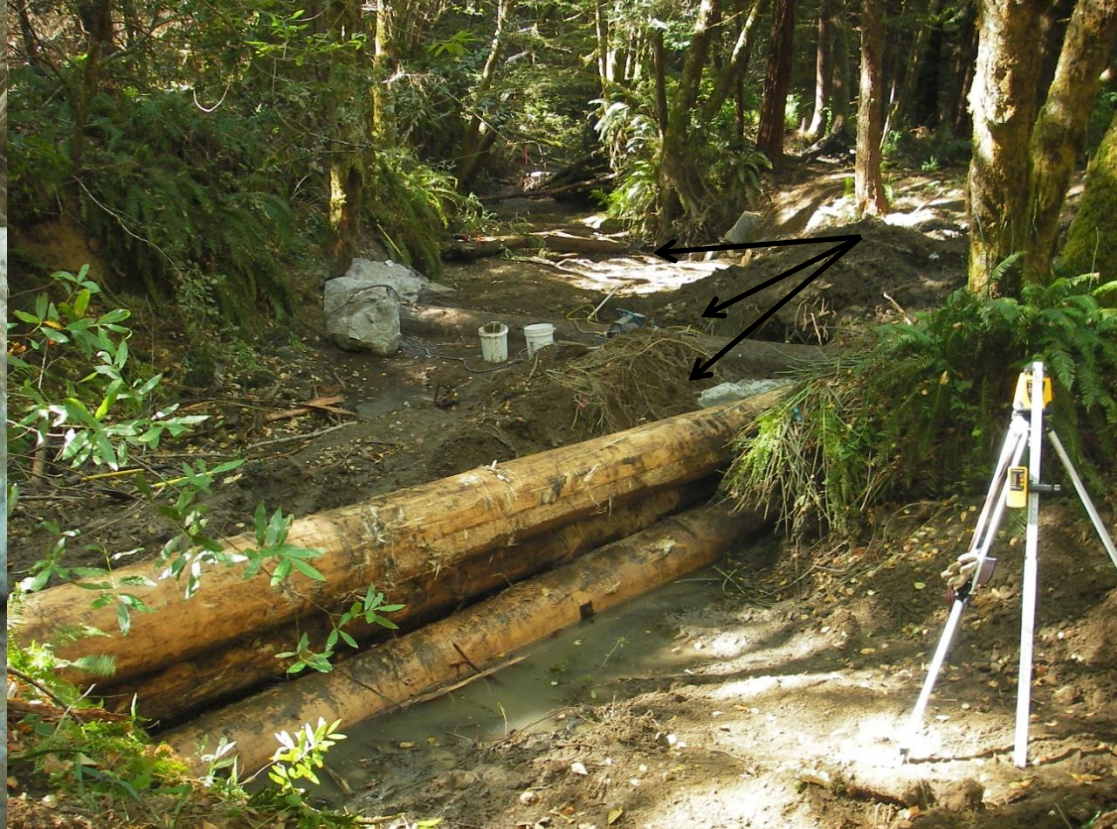
Implementation at step #3. Logs are trenched, anchored to boulders, backfilled and compacted. Trenches are partially filled with boulders anticipating some degree of restored floodplain flow. Logs are installed at target elevations to maintain jump heights and heights relative to the historic floodplain. The three primary grade control log structures are visible in lower photo with step #3 in foreground.

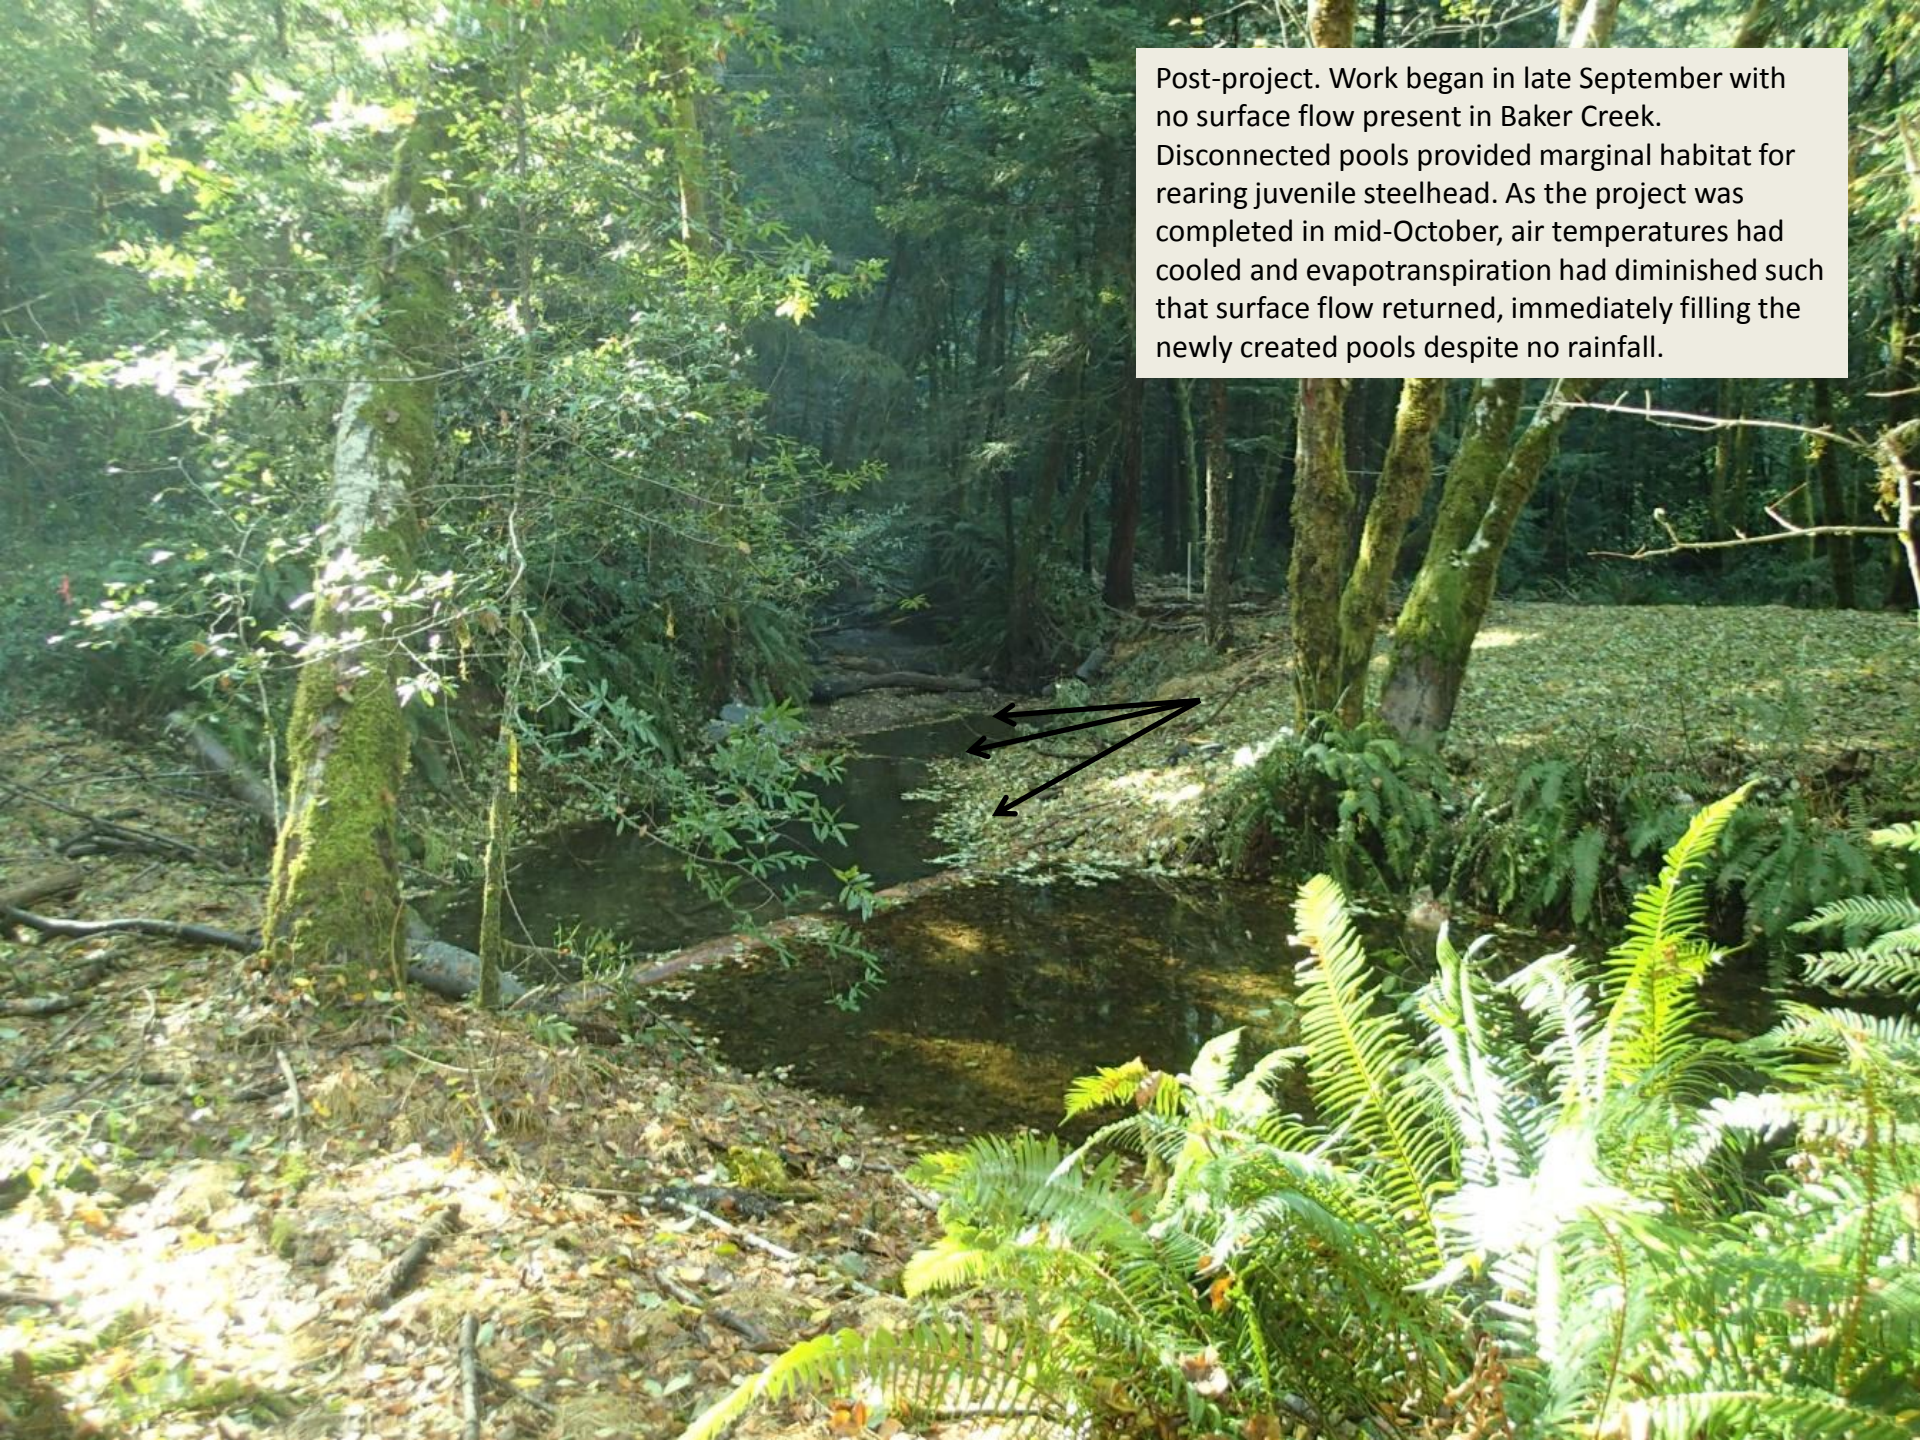
Post-project. Work began in late September with no surface flow present in Baker Creek. Disconnected pools provided marginal habitat for rearing juvenile steelhead. As the project was completed in mid-October, air temperatures had cooled and evapotranspiration had diminished such that surface flow returned, immediately filling the newly created pools despite no rainfall.

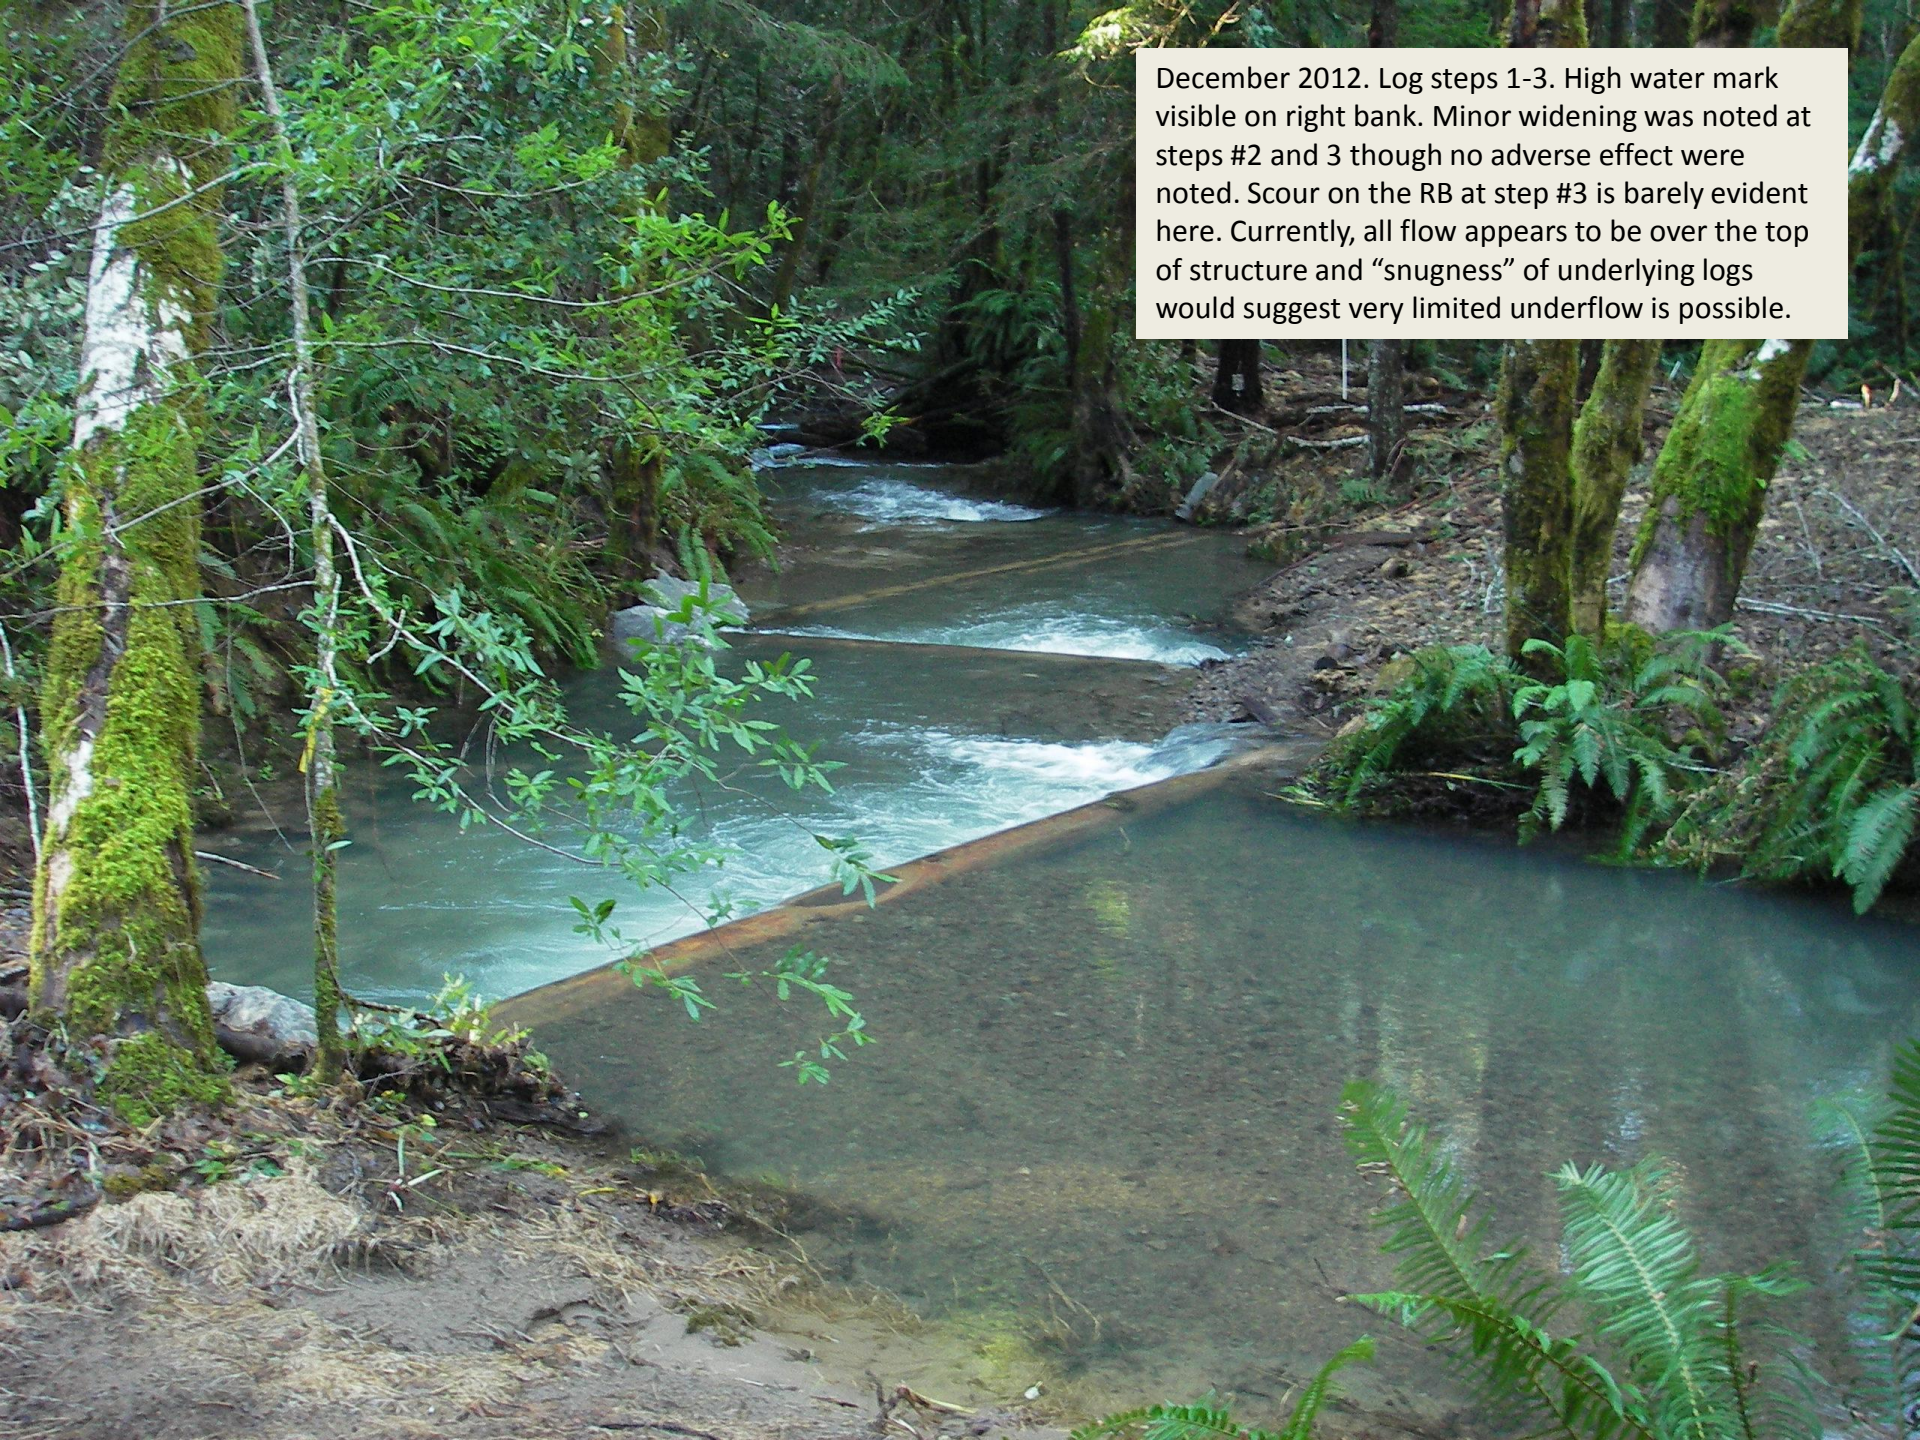
December 2012. Log steps 1-3. High water mark visible on right bank. Minor widening was noted at steps #2 and 3 though no adverse effect were noted. Scour on the RB at step #3 is barely evident here. Currently, all flow appears to be over the top of structure and “snugness” of underlying logs would suggest very limited underflow is possible.

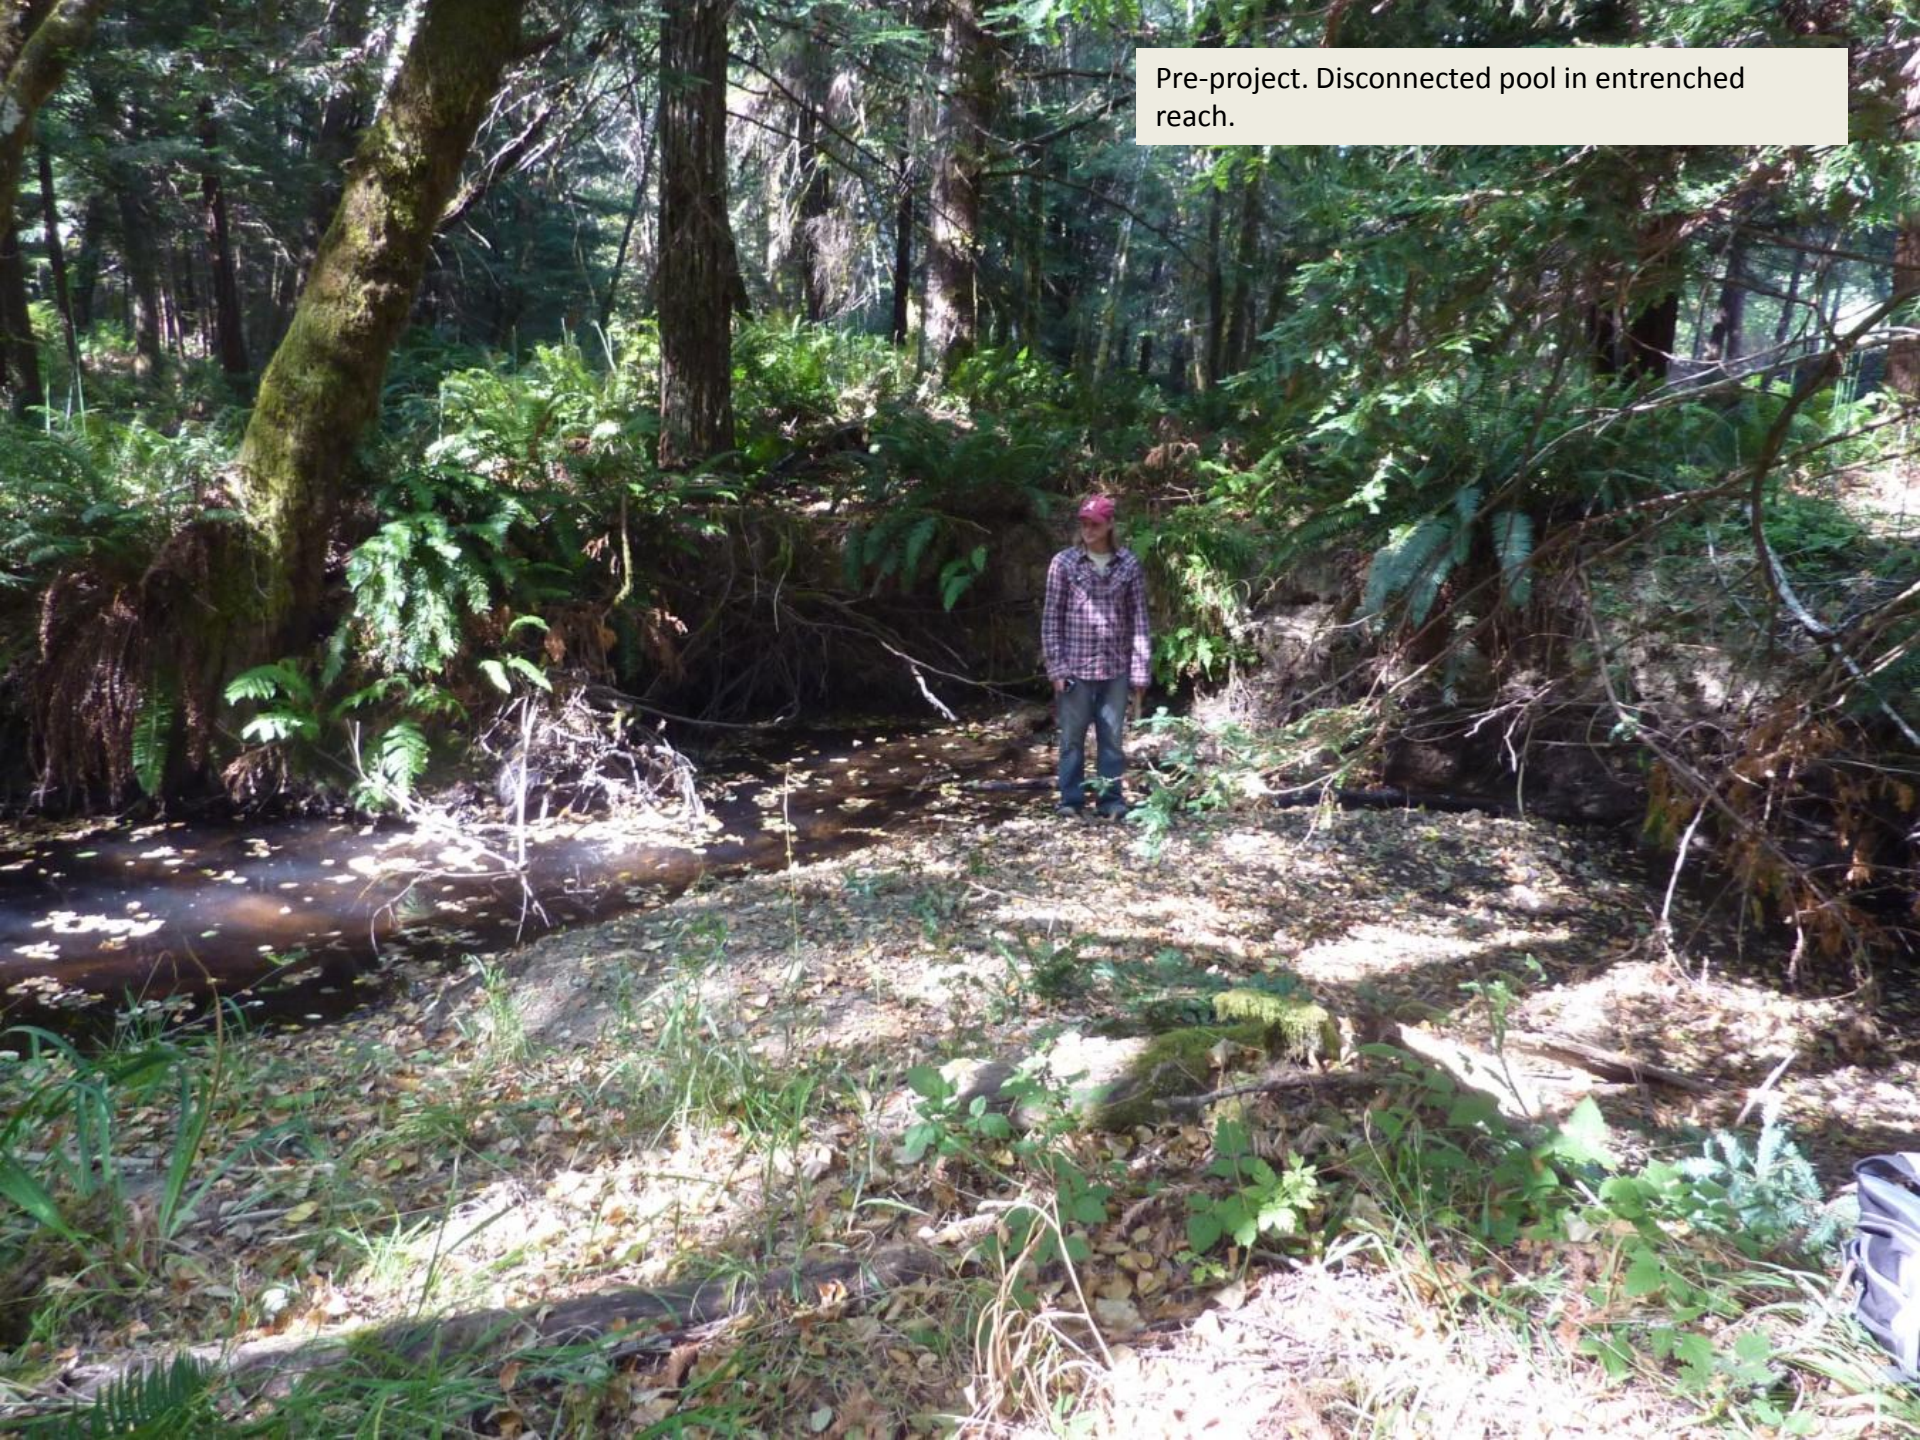
Pre-project. Disconnected pool in entrenched reach.
