Baker Creek Improvement Project

Monitoring Report to NOAA Fisheries

Year 1 Project Summary

Mattole River Watershed
BLM Arcata Field Office

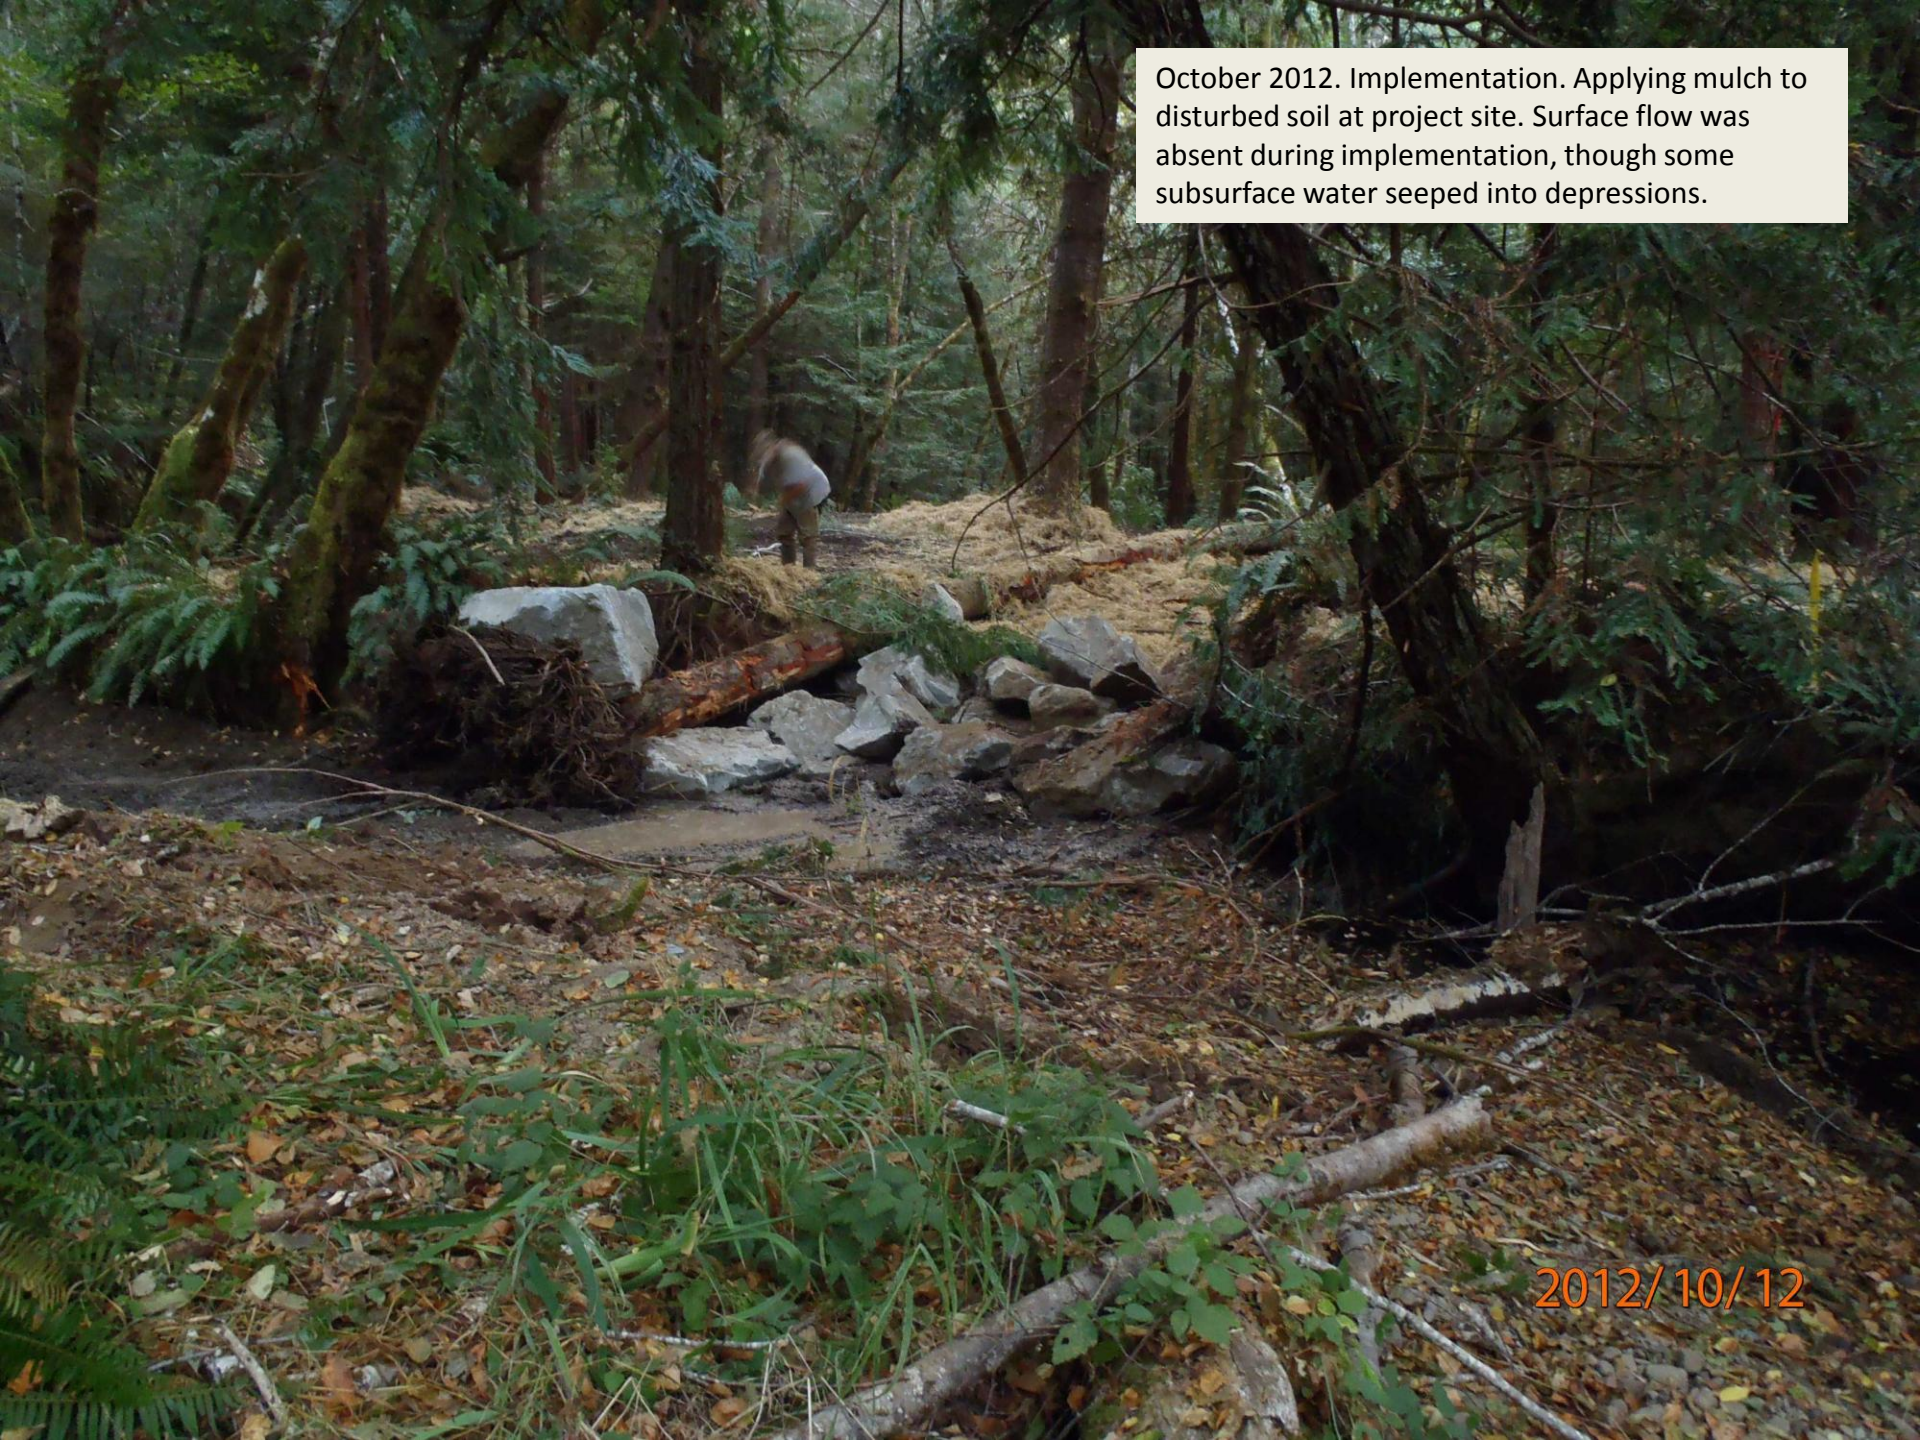
October 2012. Implementation. Applying mulch to disturbed soil at project site. Surface flow was absent during implementation, though some subsurface water seeped into depressions.

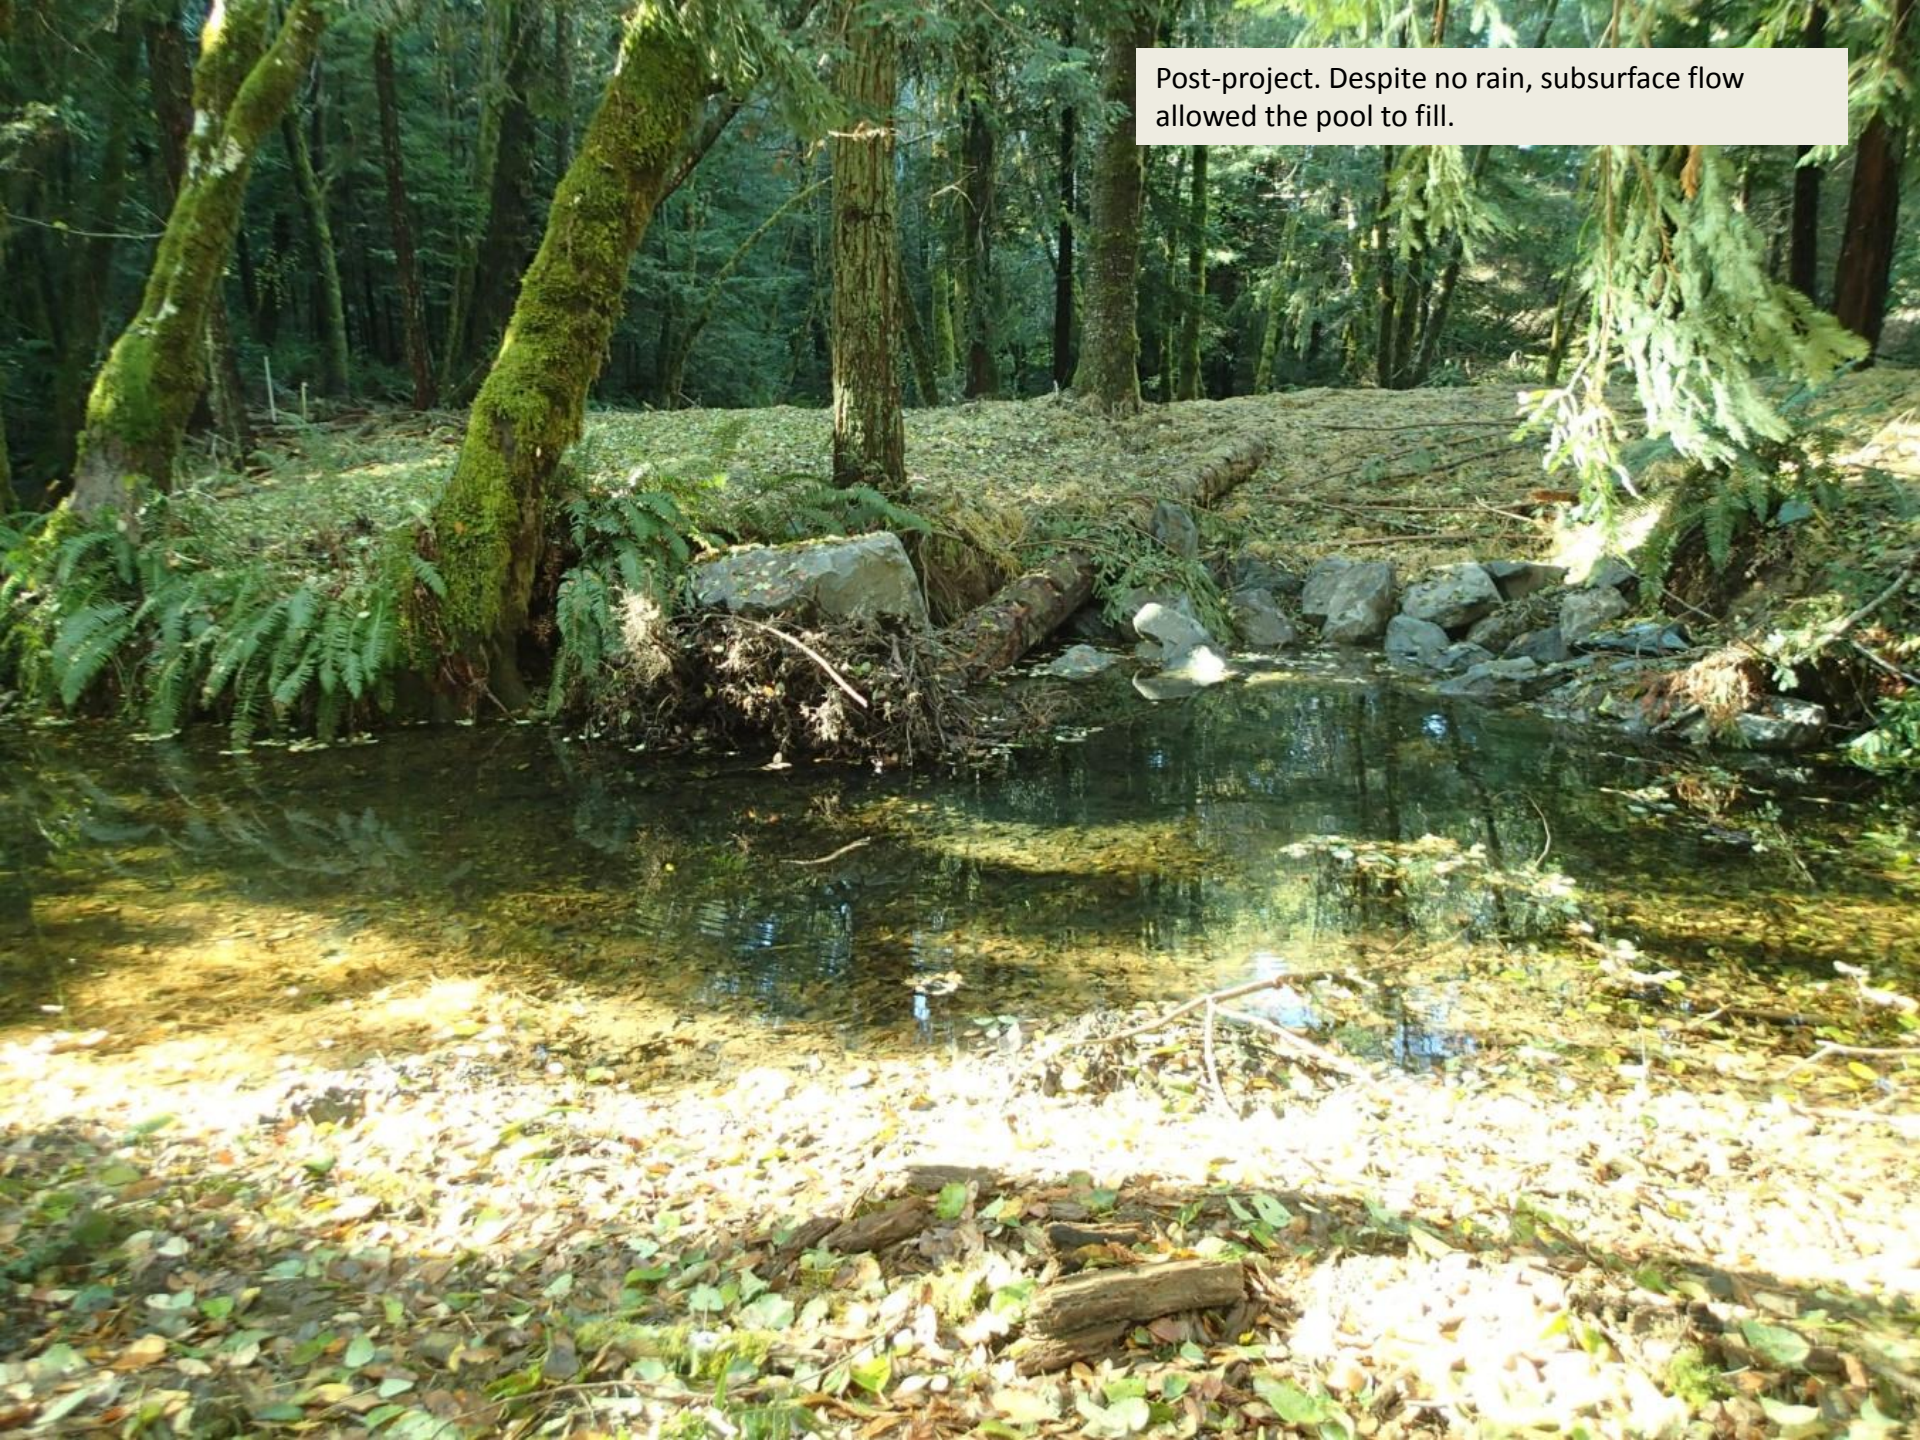
Post-project. Despite no rain, subsurface flow allowed the pool to fill.

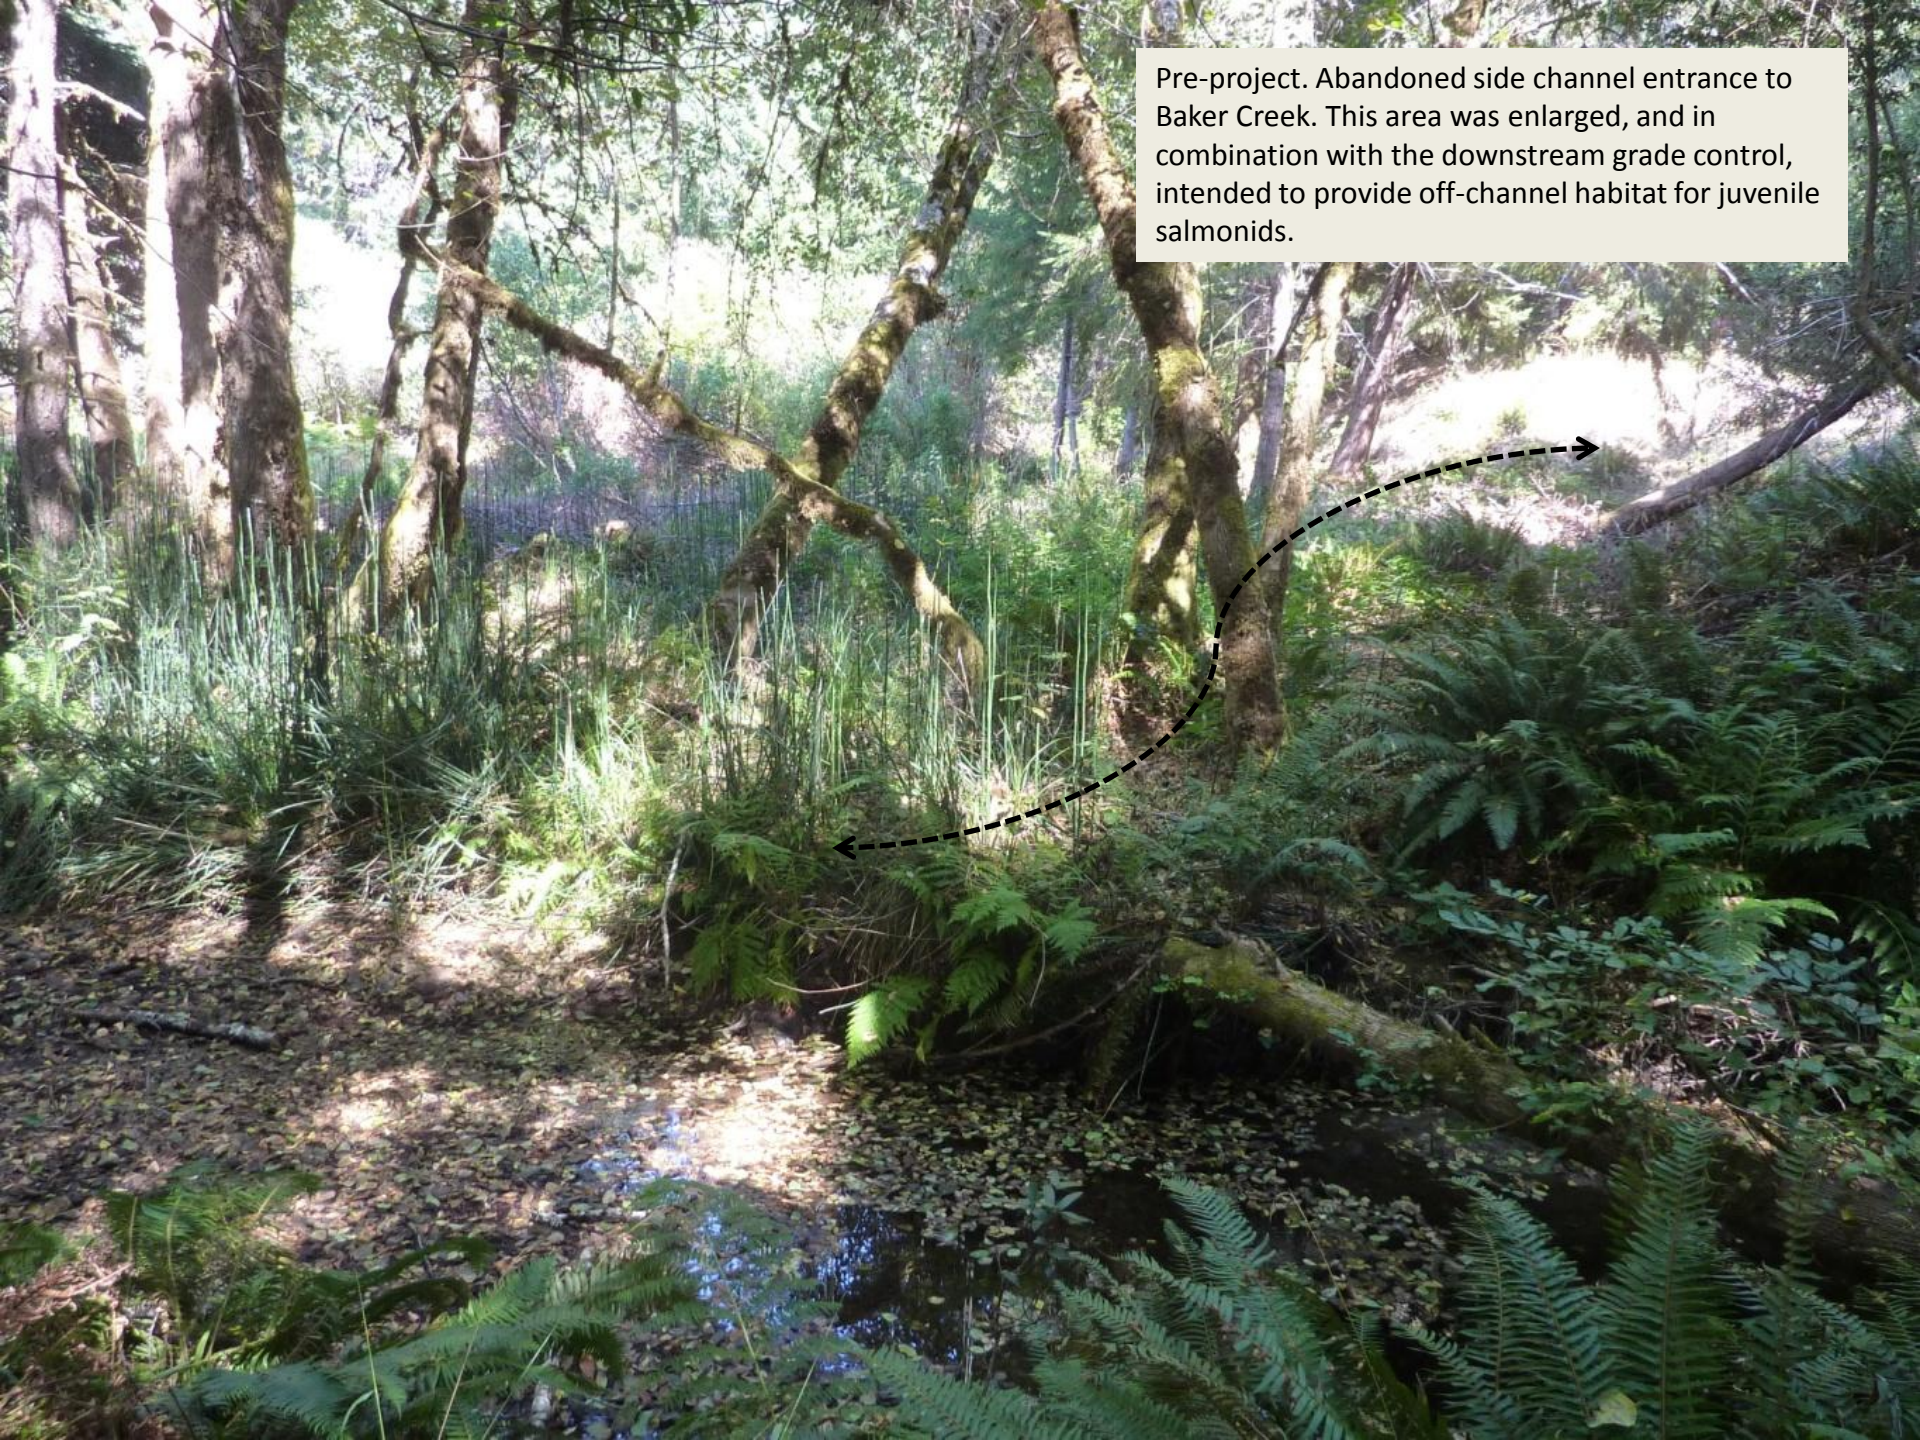
Pre-project. Abandoned side channel entrance to Baker Creek. This area was enlarged, and in combination with the downstream grade control, intended to provide off-channel habitat for juvenile salmonids.

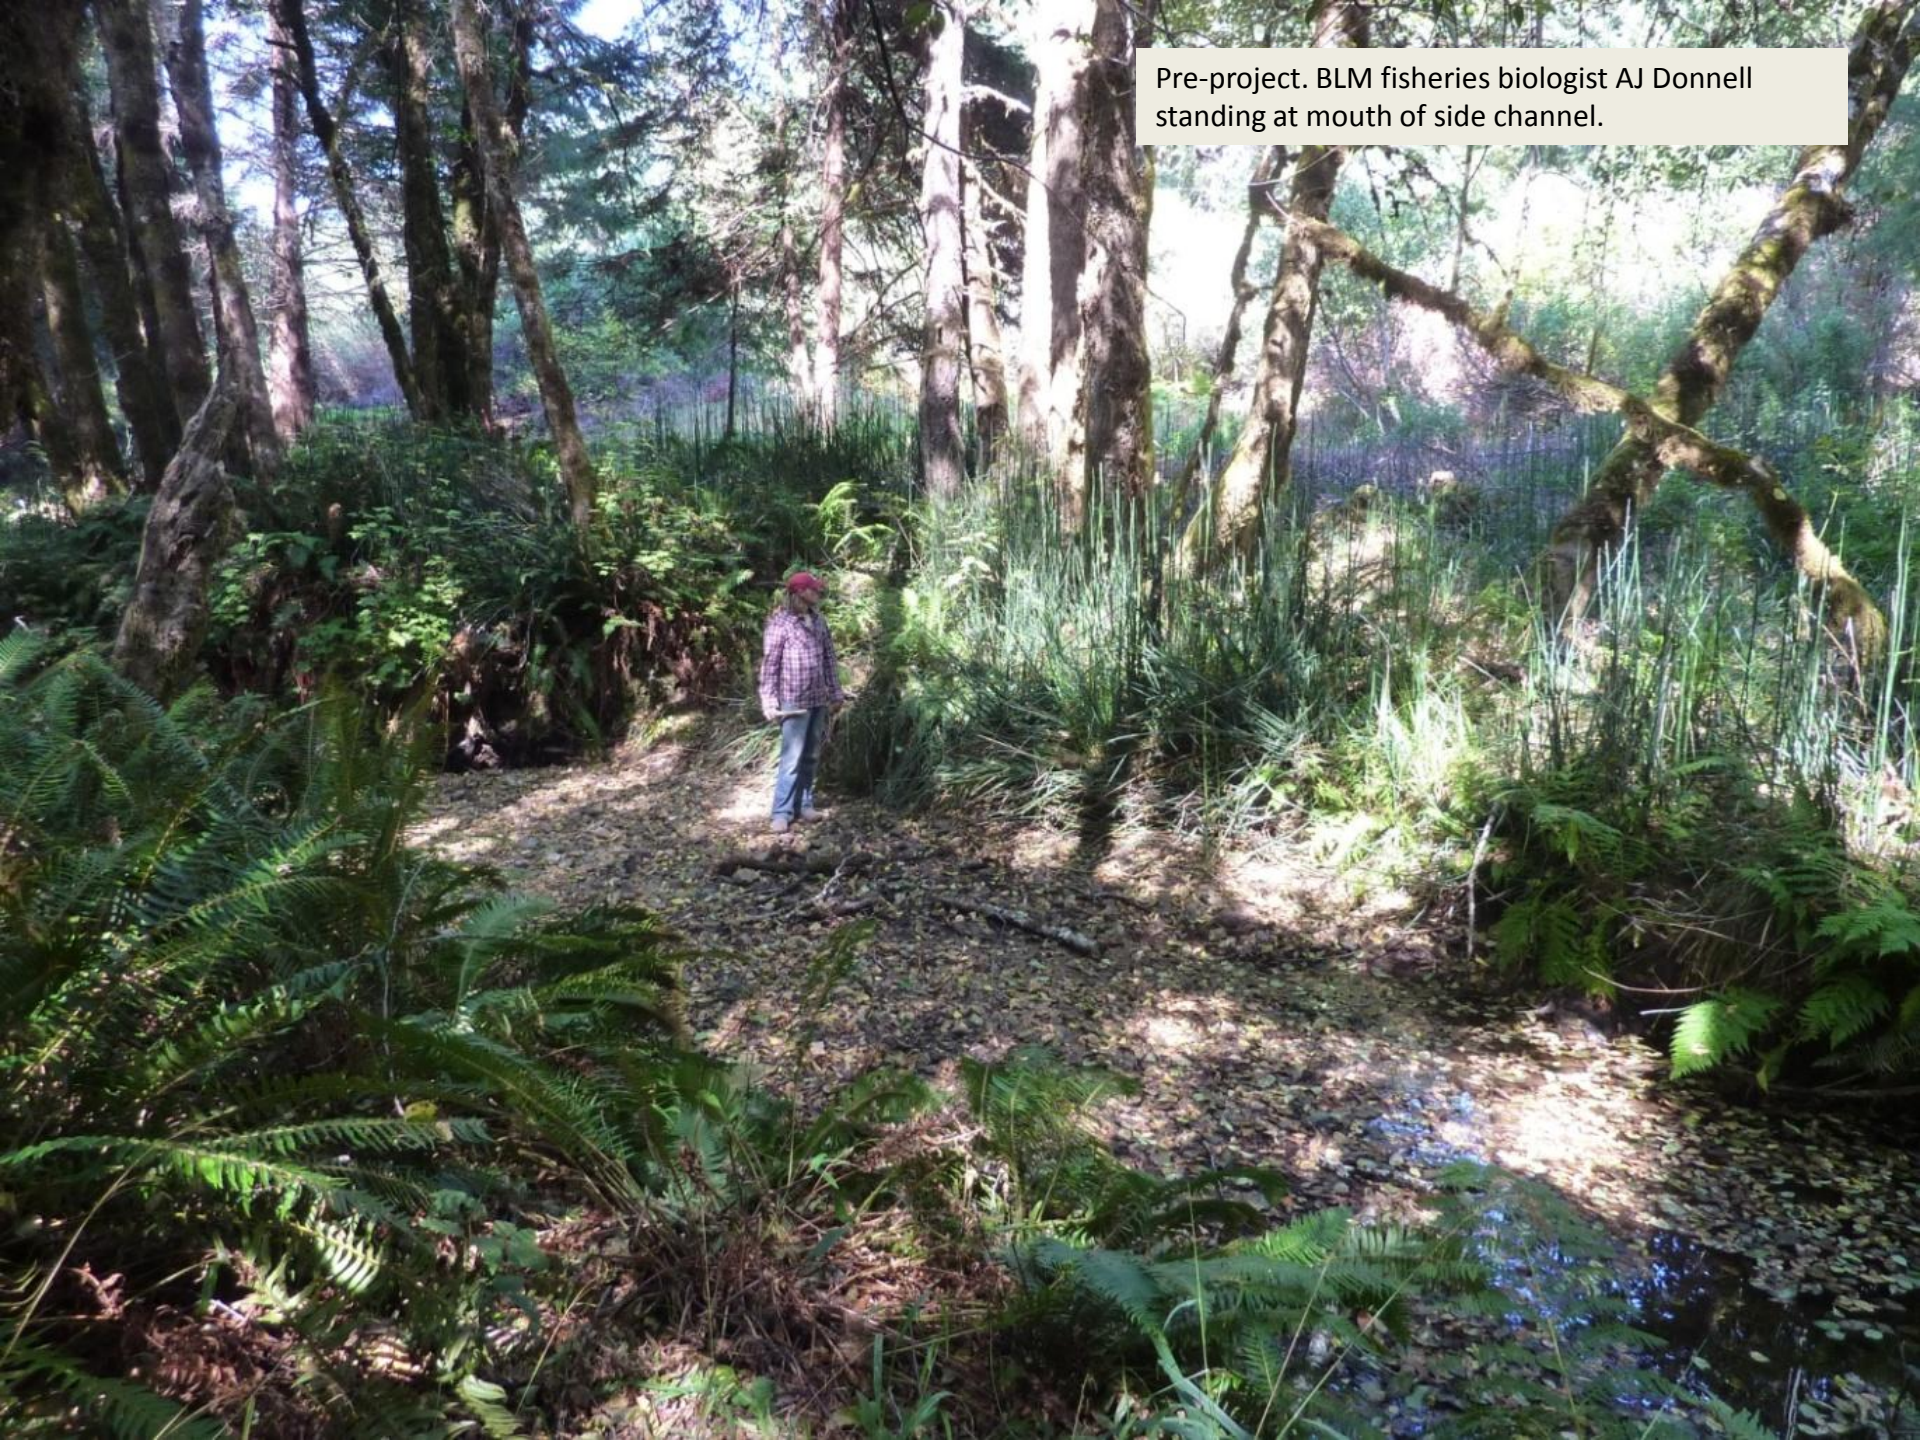
Pre-project. BLM fisheries biologist AJ Donnell standing at mouth of side channel.

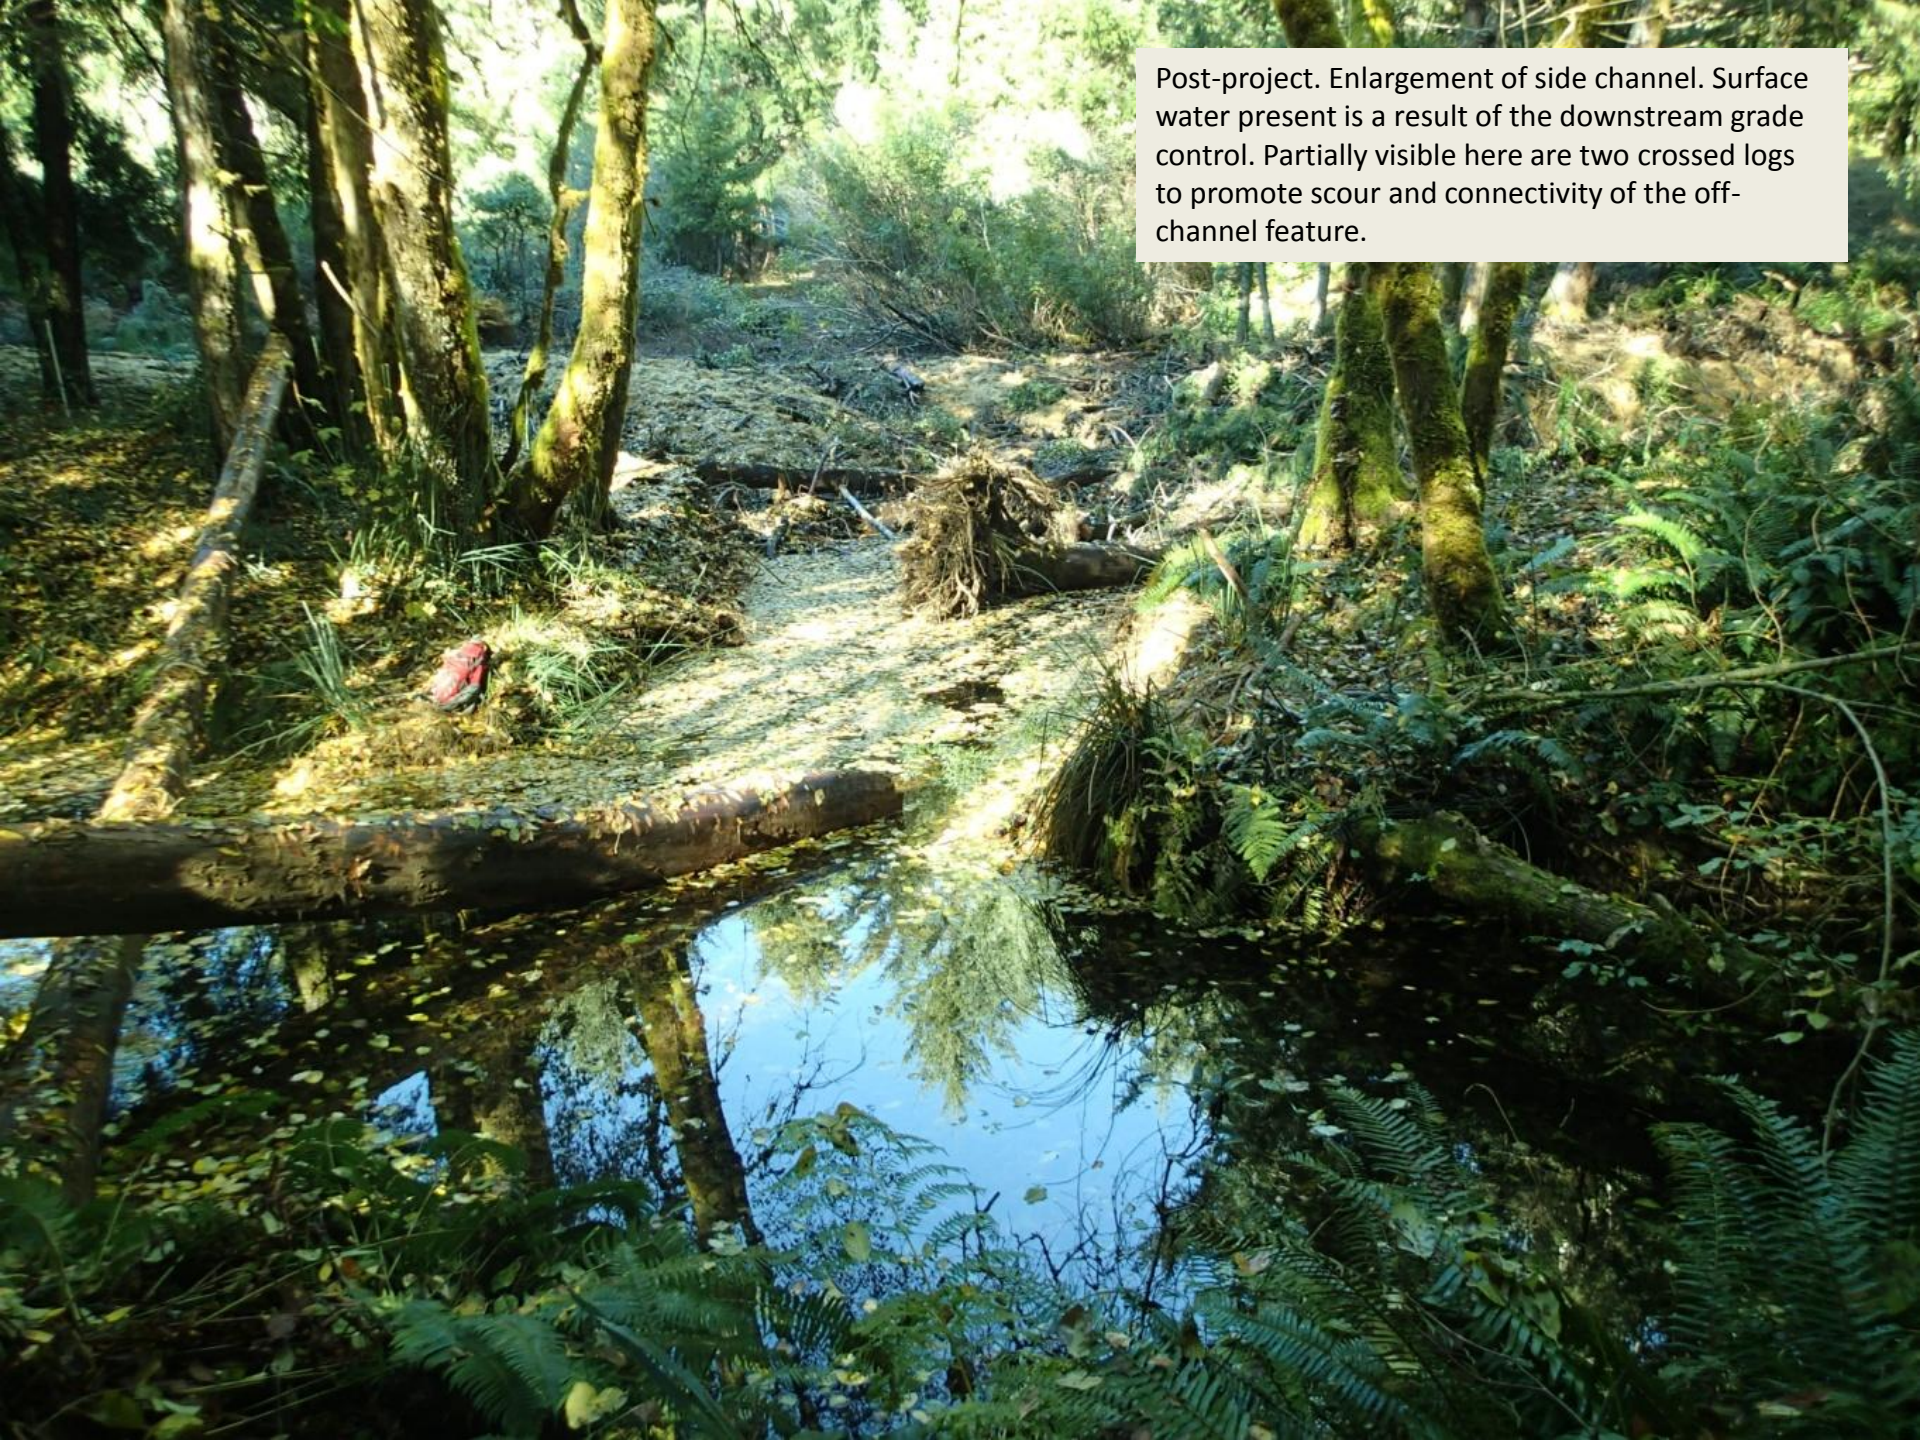
Post-project. Enlargement of side channel. Surface water present is a result of the downstream grade control. Partially visible here are two crossed logs to promote scour and connectivity of the off-channel feature.

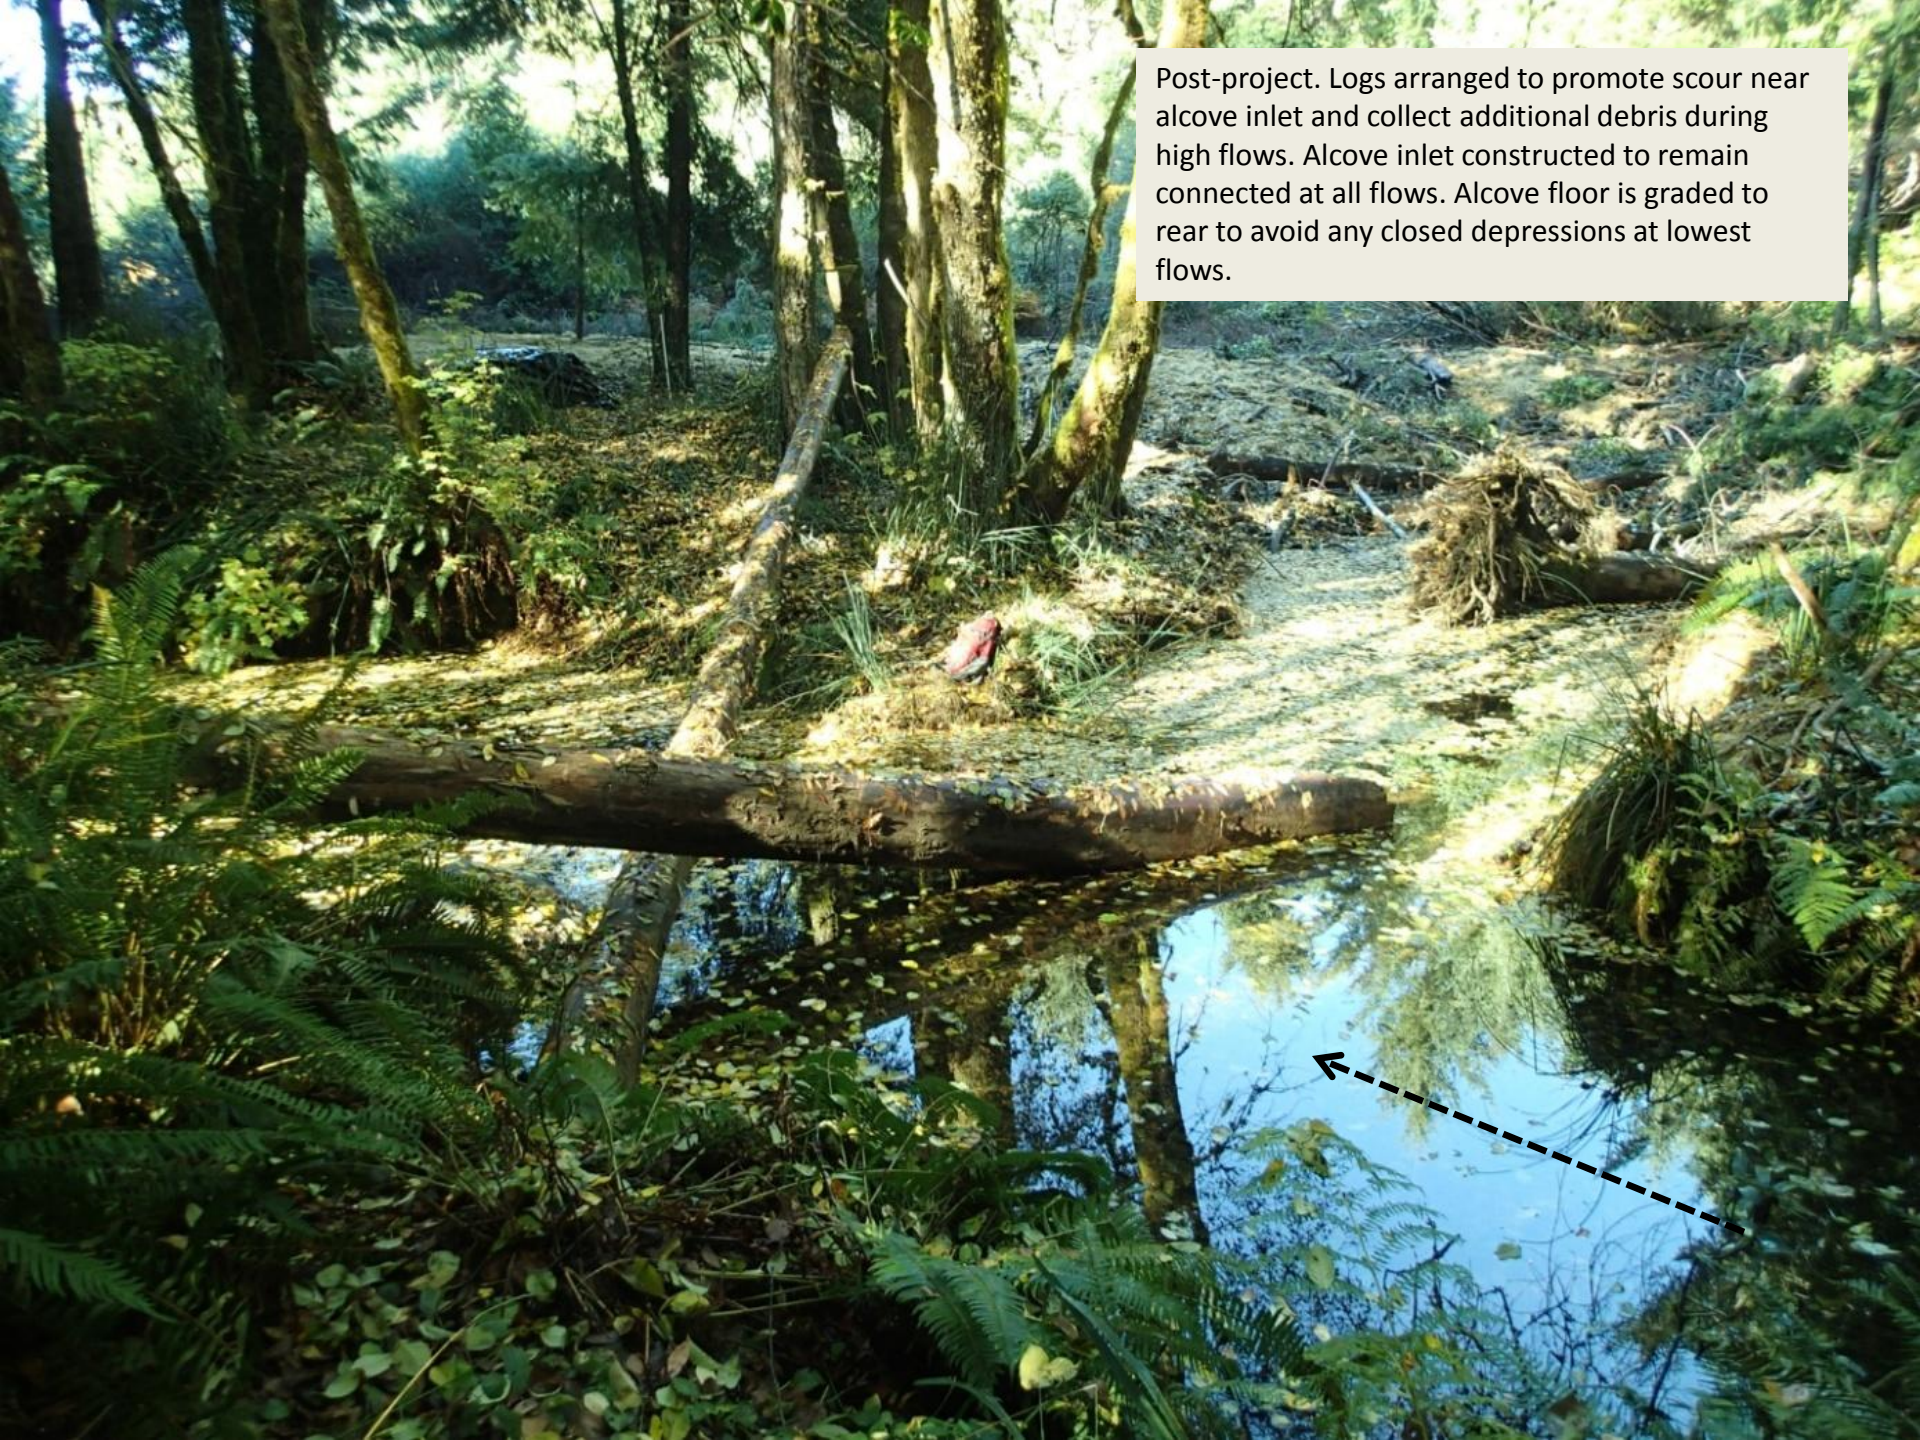
Post-project. Logs arranged to promote scour near alcove inlet and collect additional debris during high flows. Alcove inlet constructed to remain connected at all flows. Alcove floor is graded to rear to avoid any closed depressions at lowest flows.

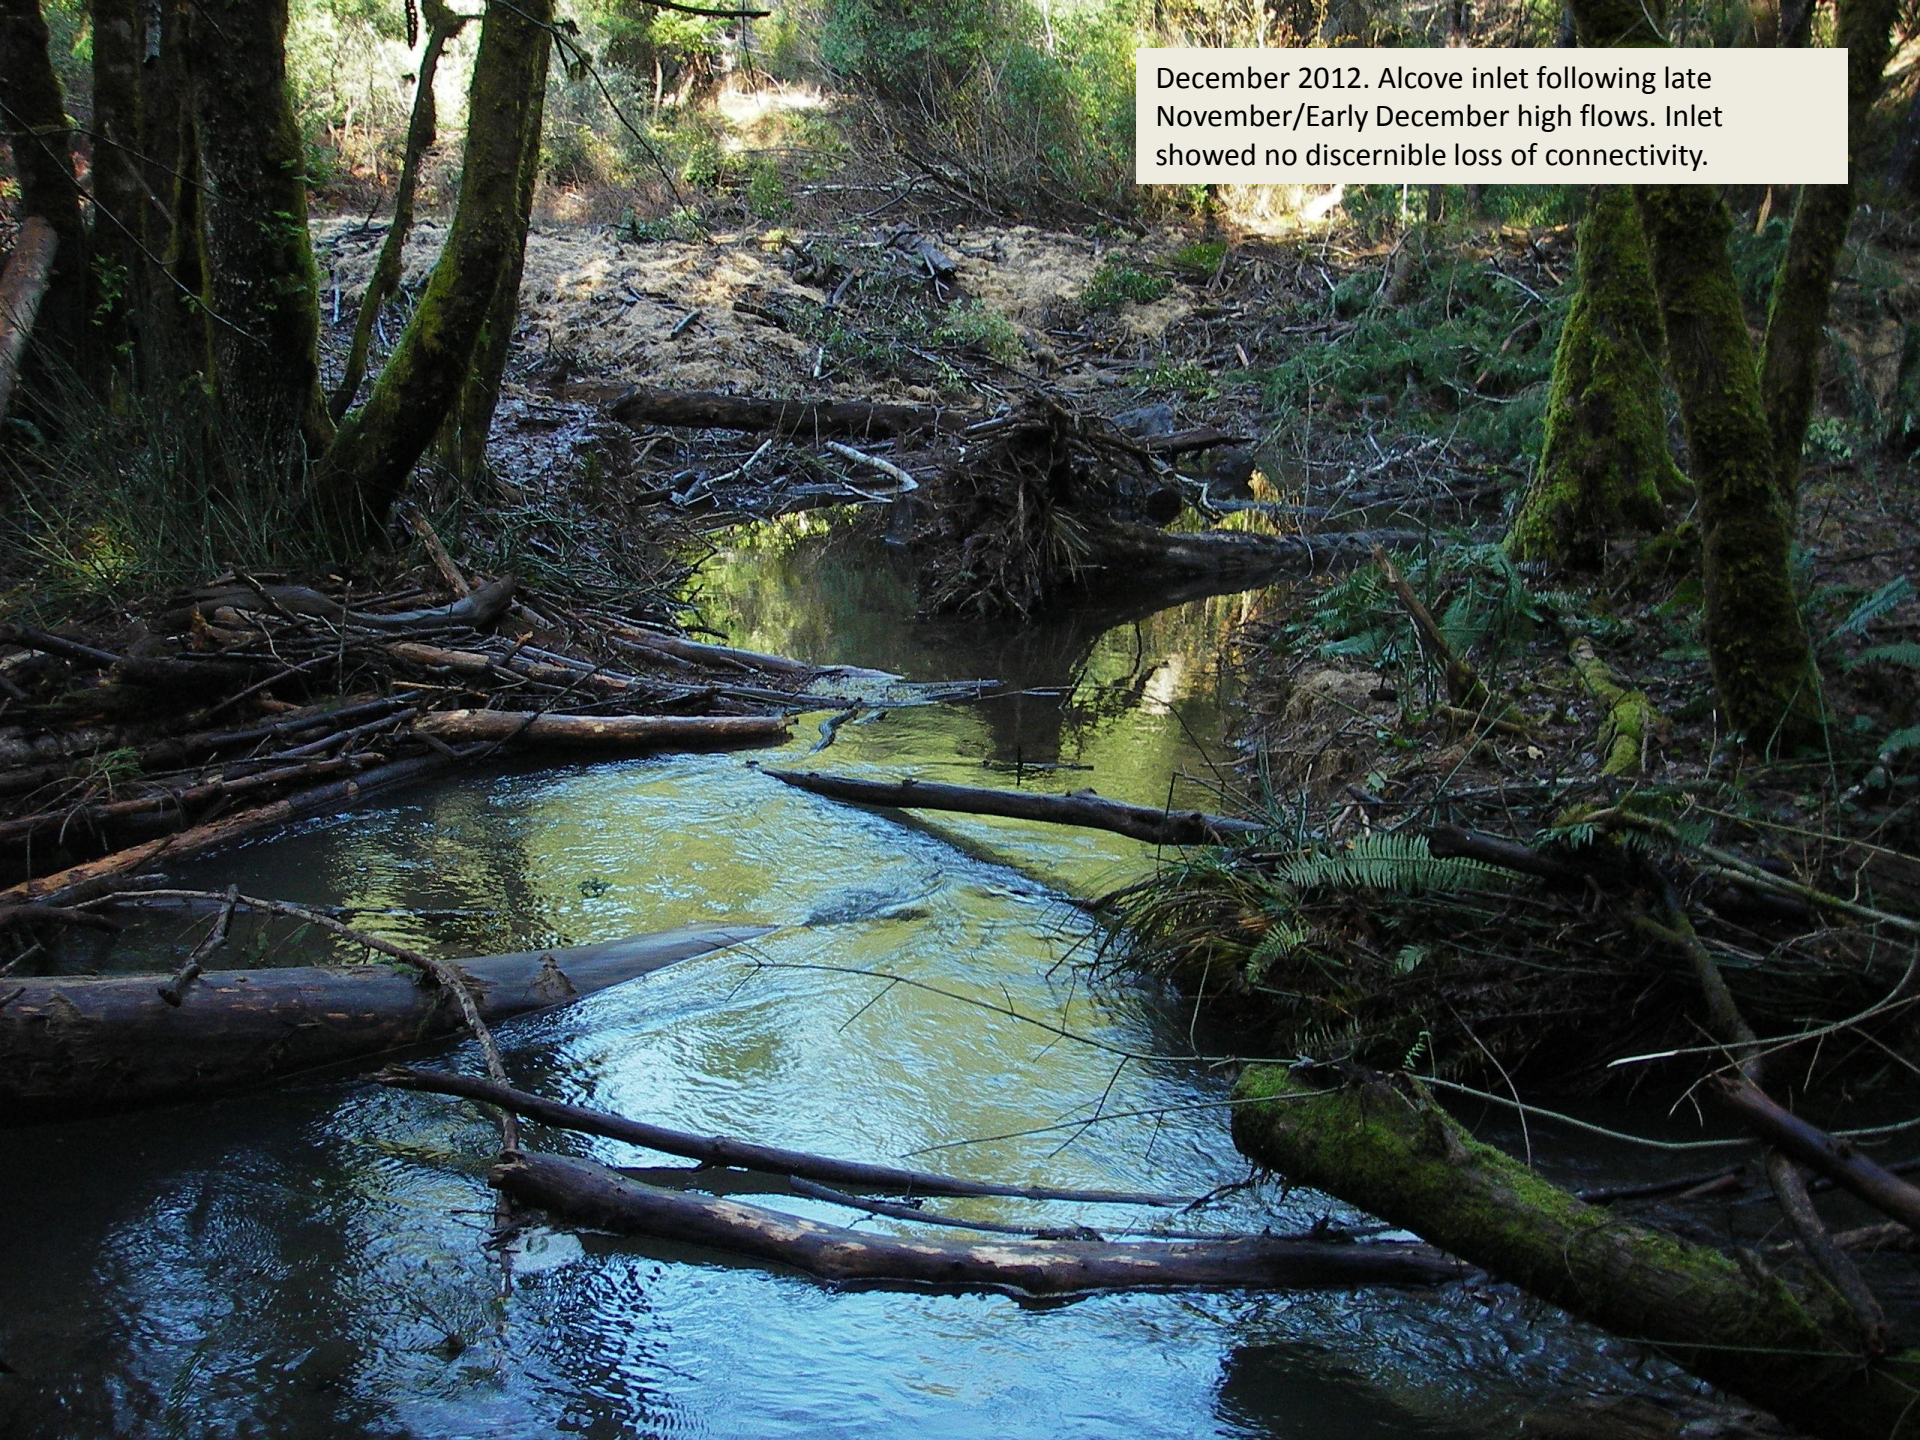
December 2012. Alcove inlet following late November/Early December high flows. Inlet showed no discernible loss of connectivity.

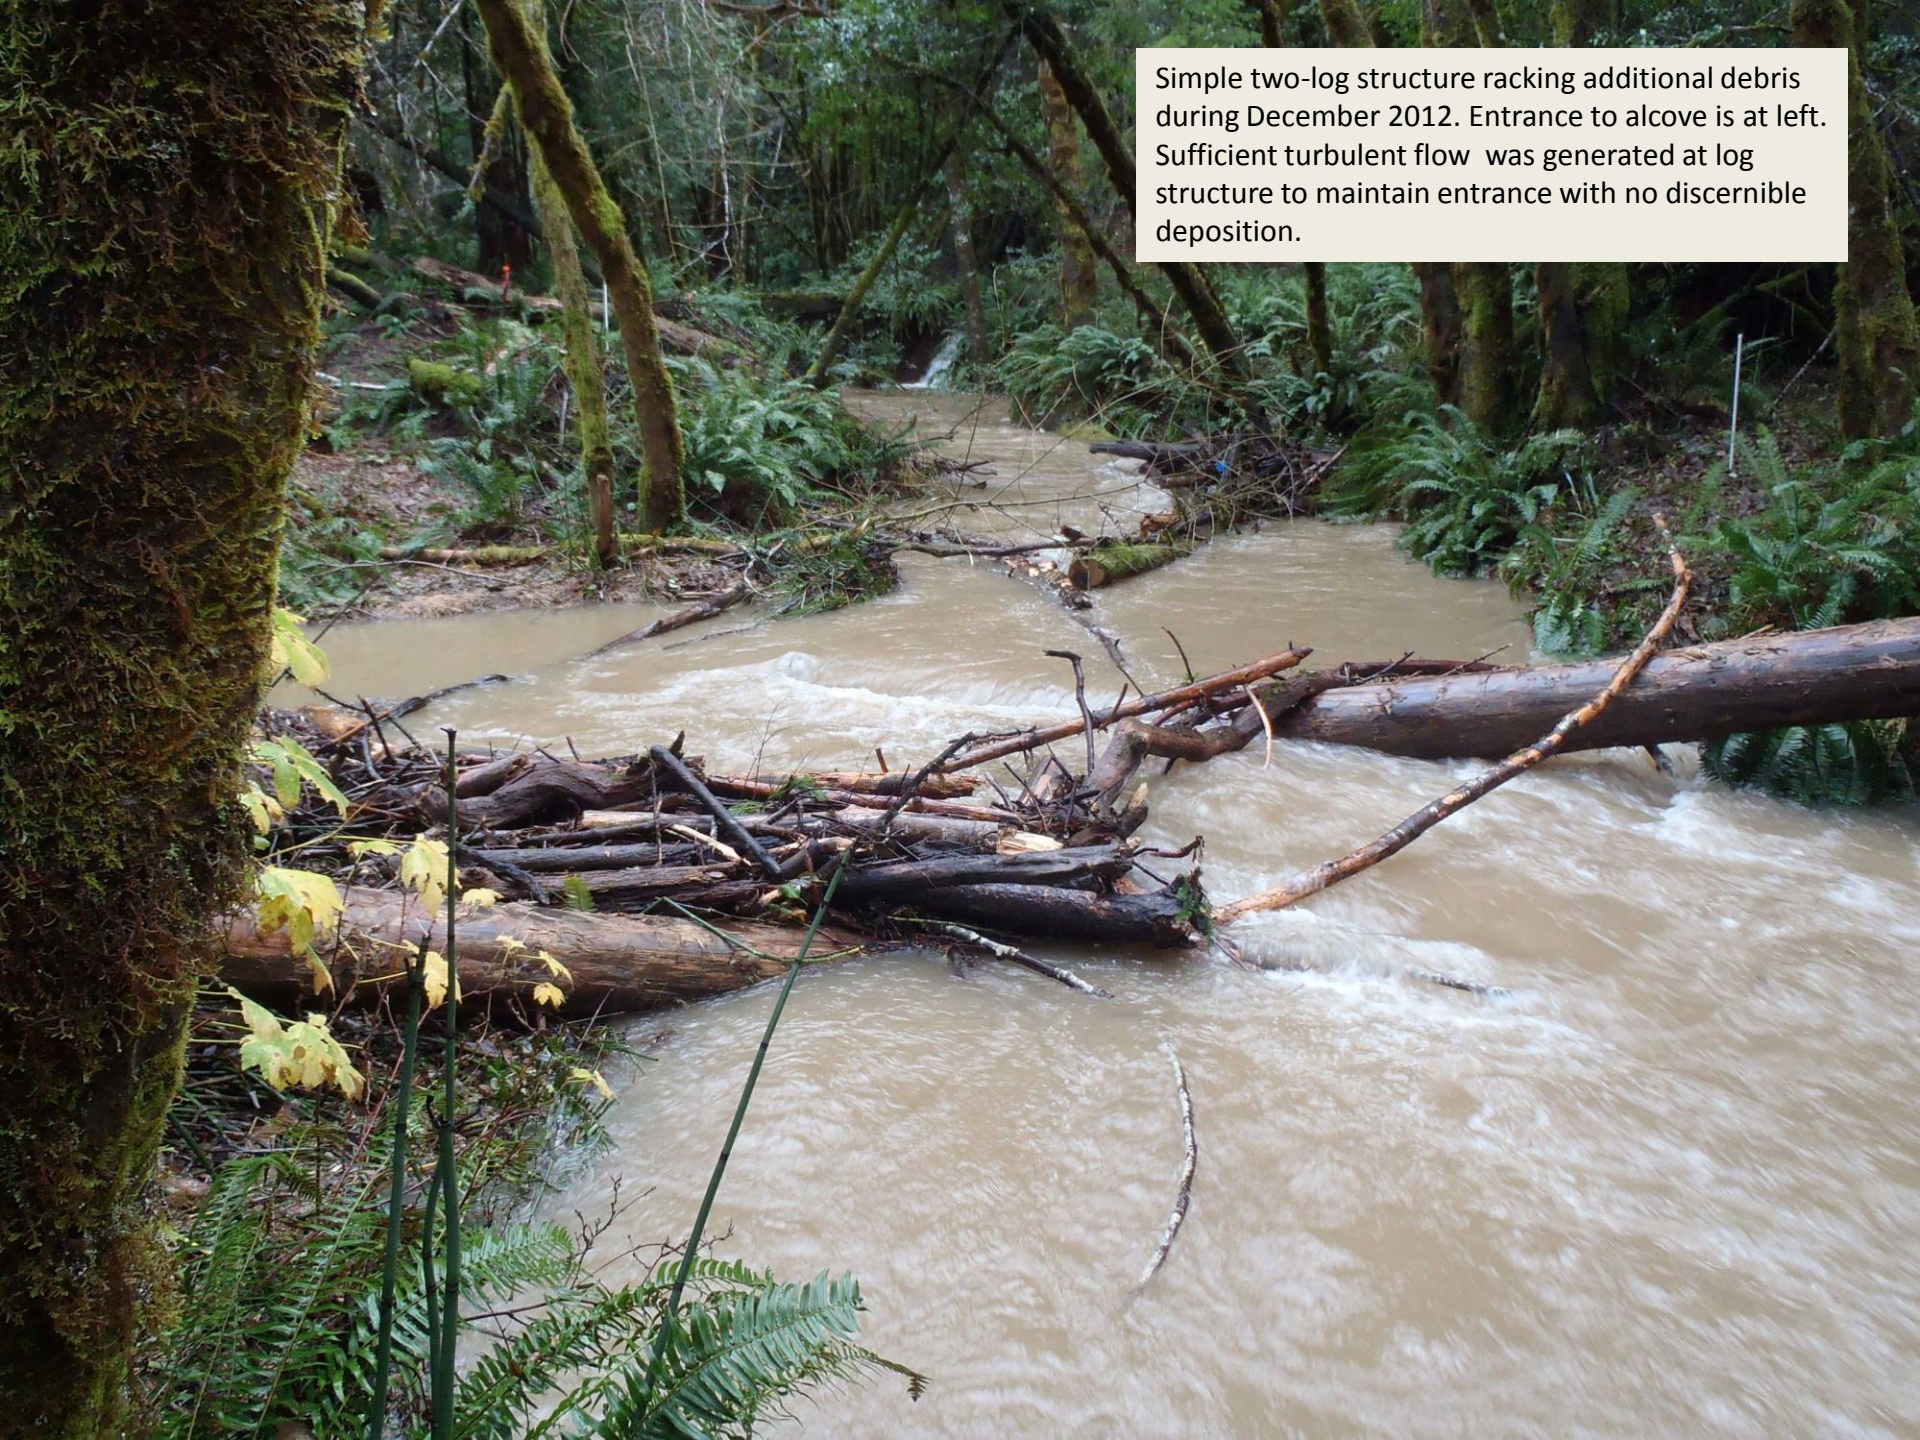
Simple two-log structure racking additional debris during December 2012. Entrance to alcove is at left. Sufficient turbulent flow was generated at log structure to maintain entrance with no discernible deposition.
