Baker Creek Improvement Project

Monitoring Report to NOAA Fisheries

Year 1 Project Summary

Mattole River Watershed
BLM Arcata Field Office

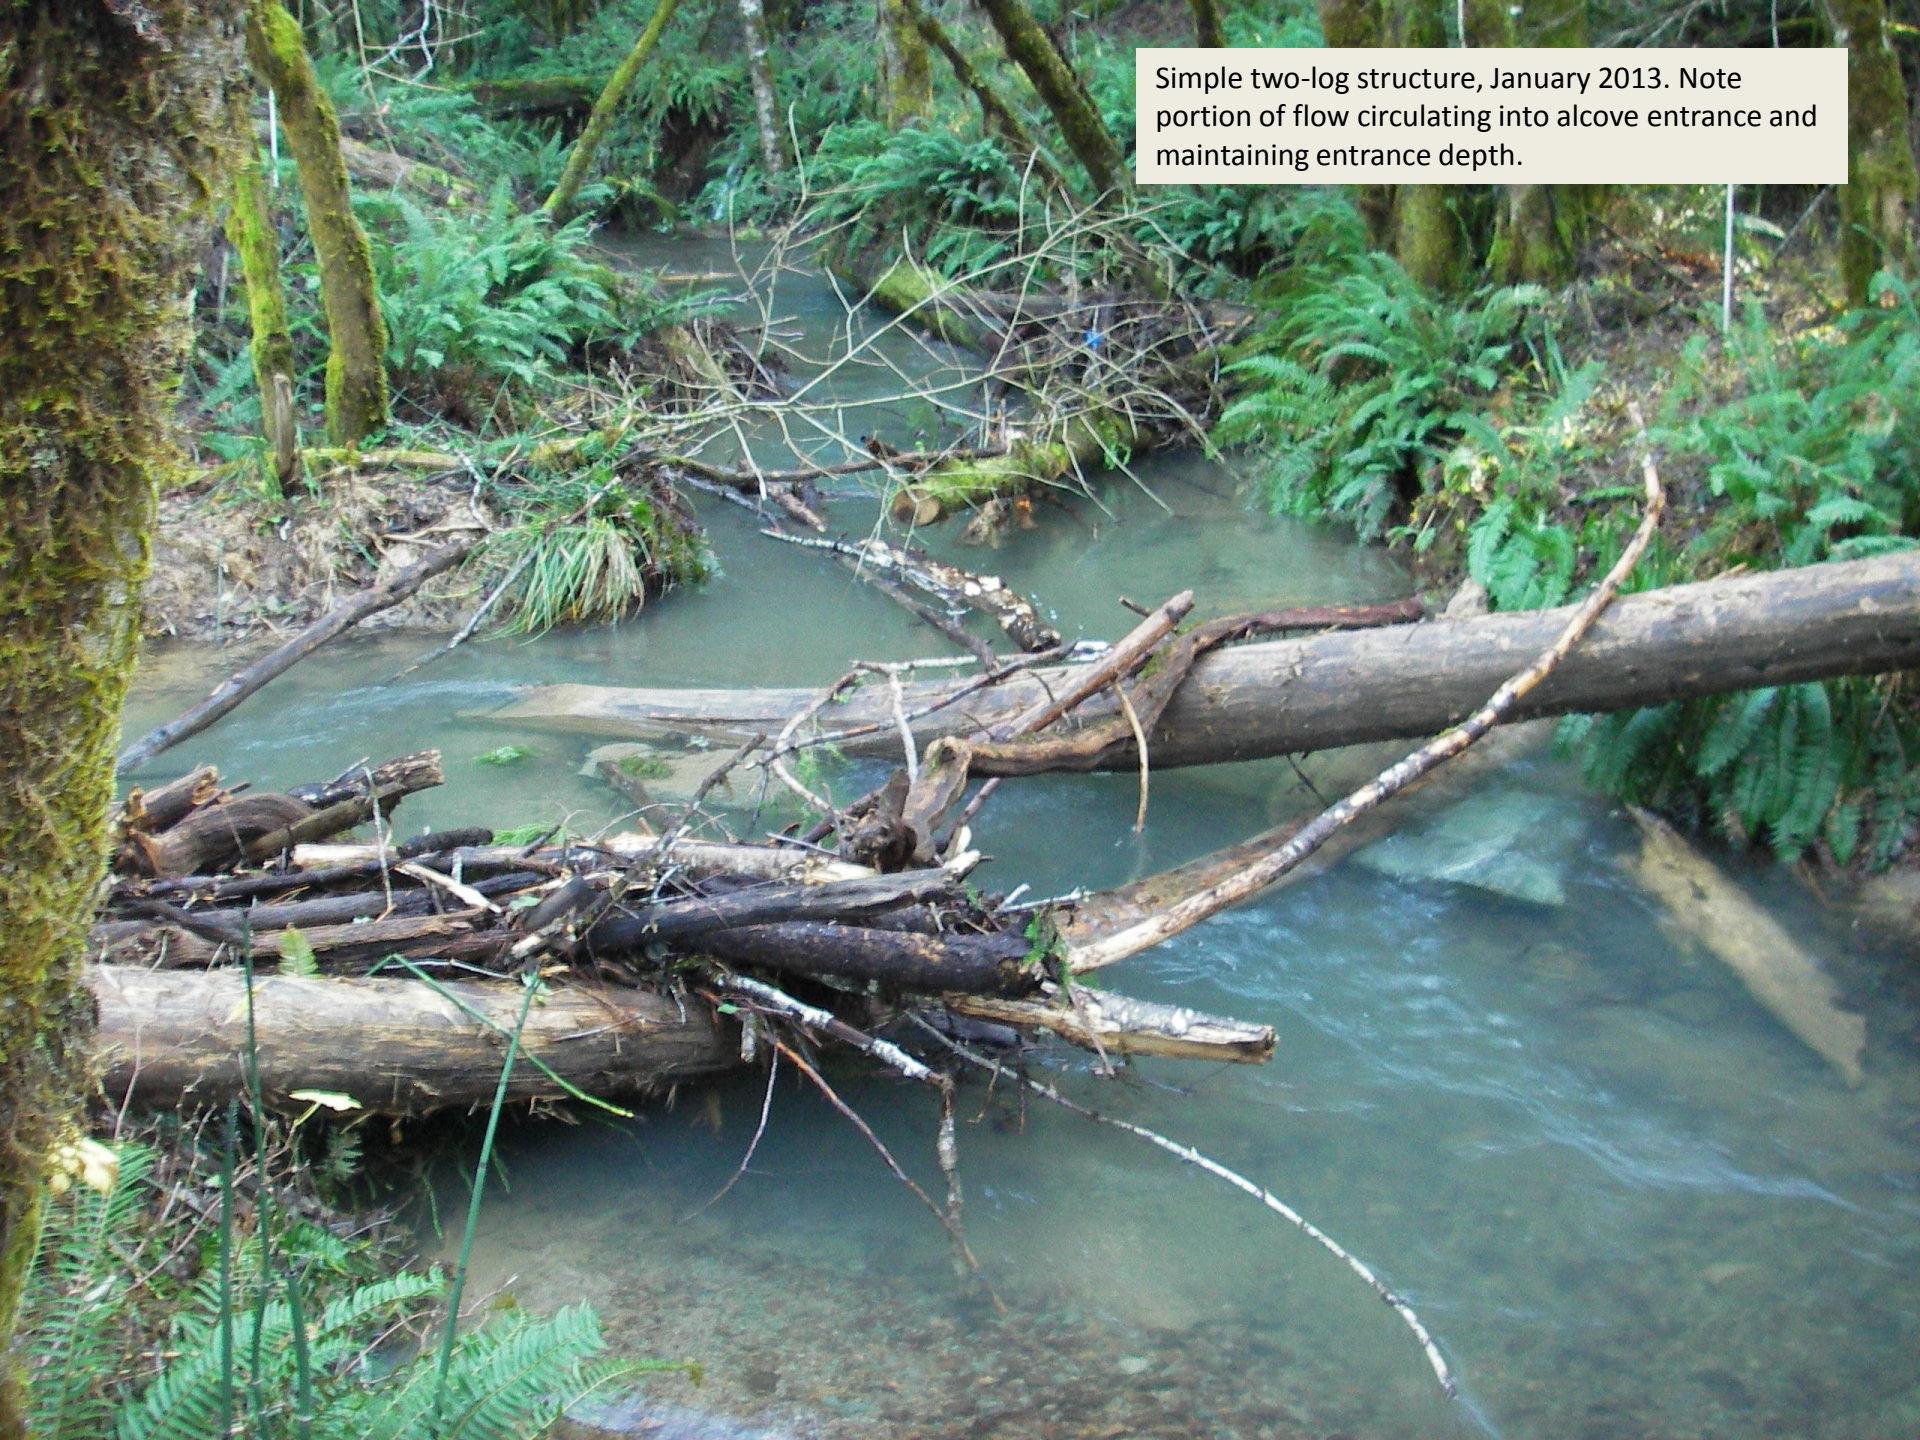
Simple two-log structure, January 2013. Note portion of flow circulating into alcove entrance and maintaining entrance depth.

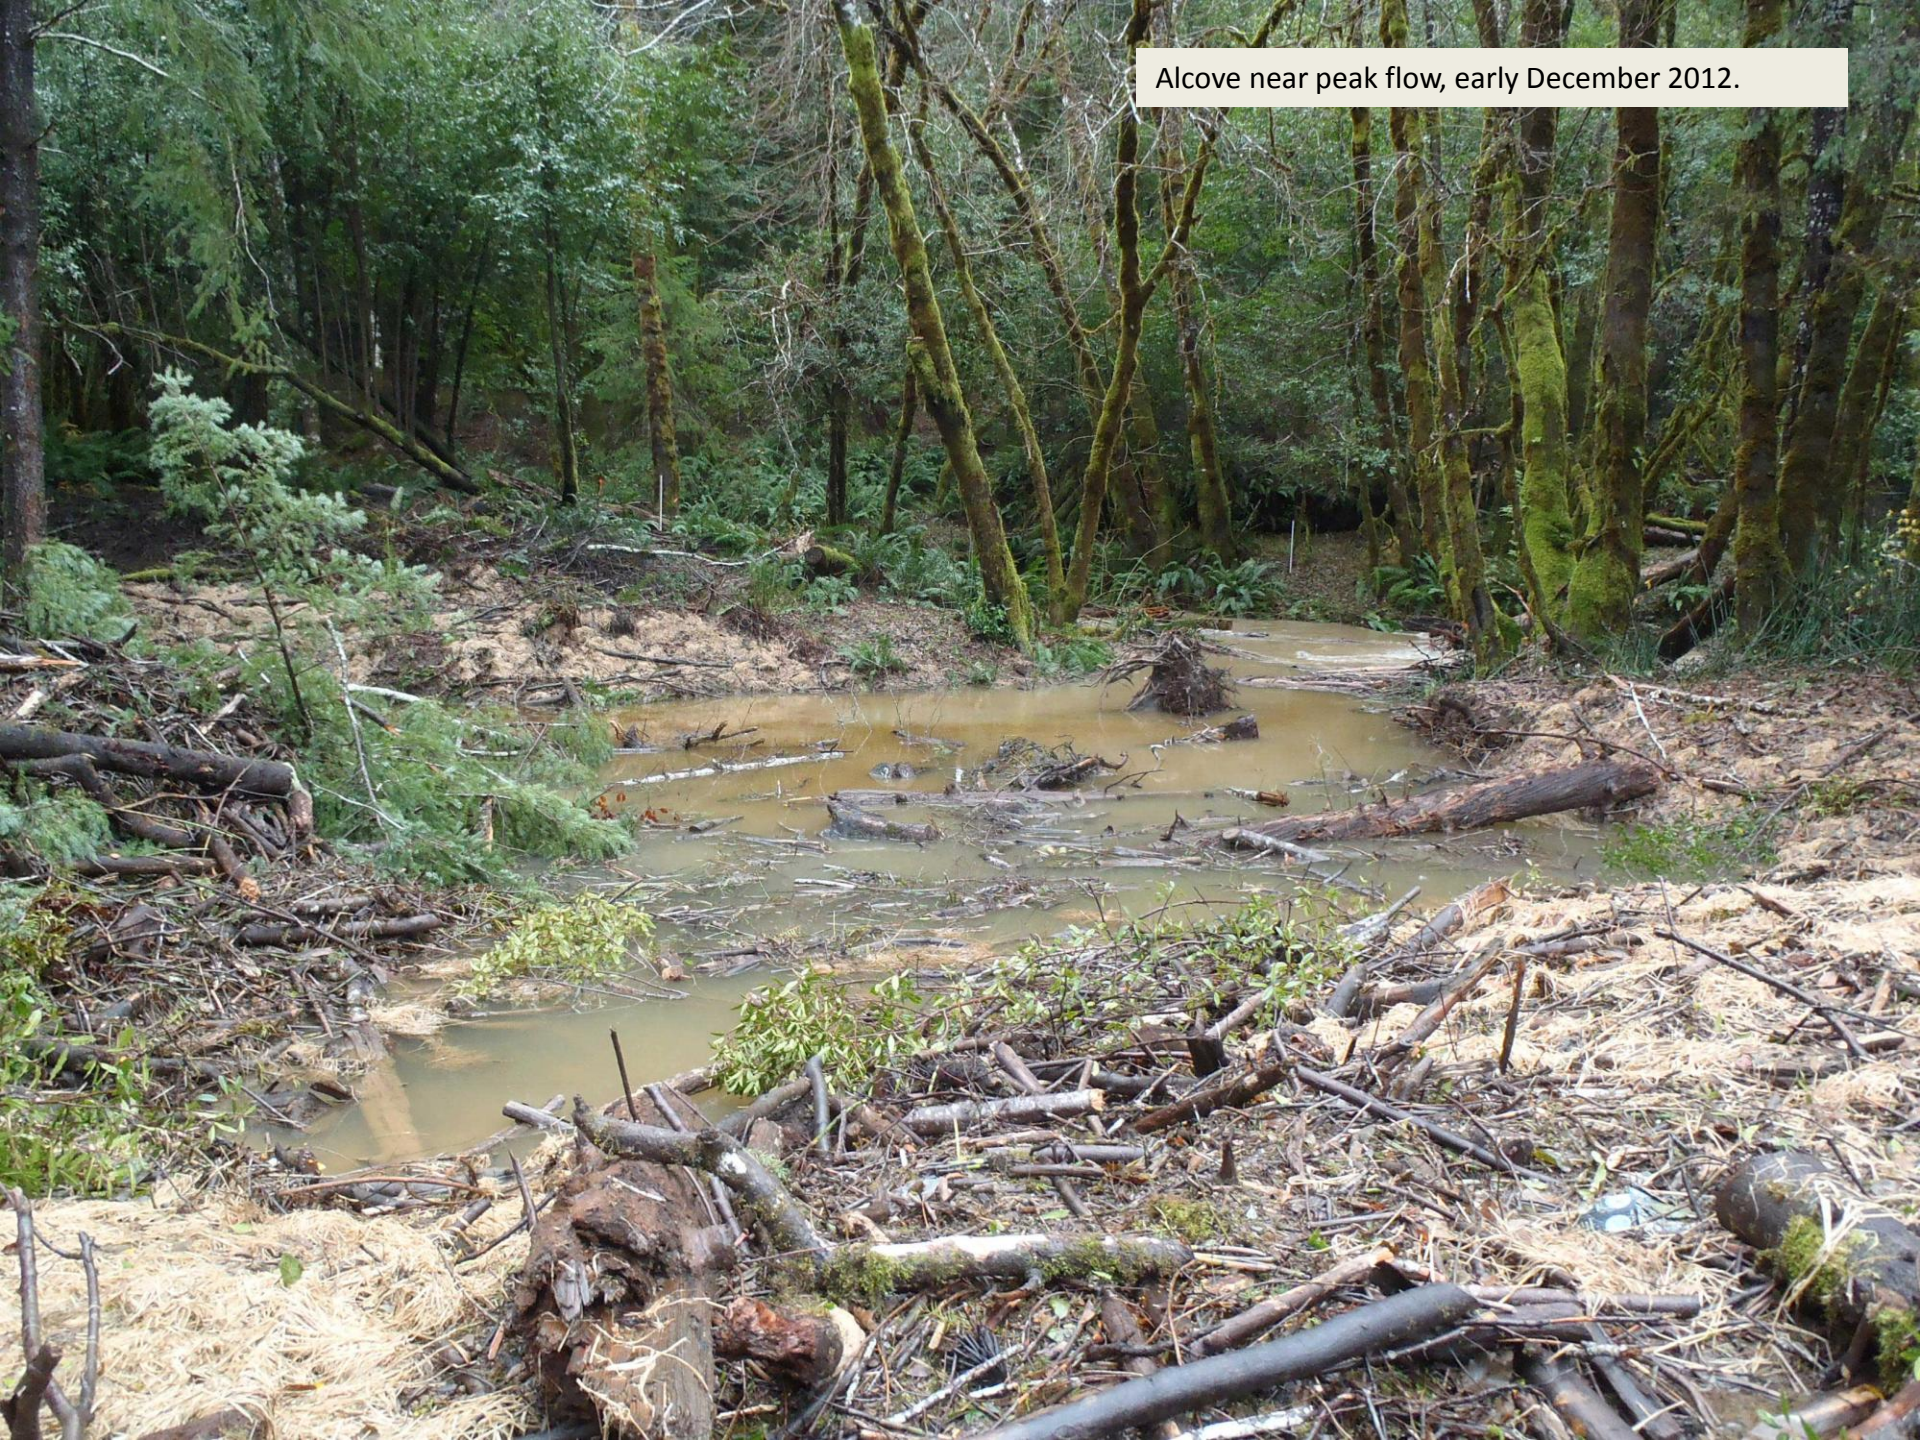
Alcove near peak flow, early December 2012.
