# Salt River Ecosystem Restoration Project

## Monitoring Report 2015

Finalized September 2016

Prepared by the Humboldt County Resource Conservation District  
5630 South Broadway  
Eureka, CA 95503  
707.444.9708  
[hcrd@gmail.com](mailto:hcrd@gmail.com)

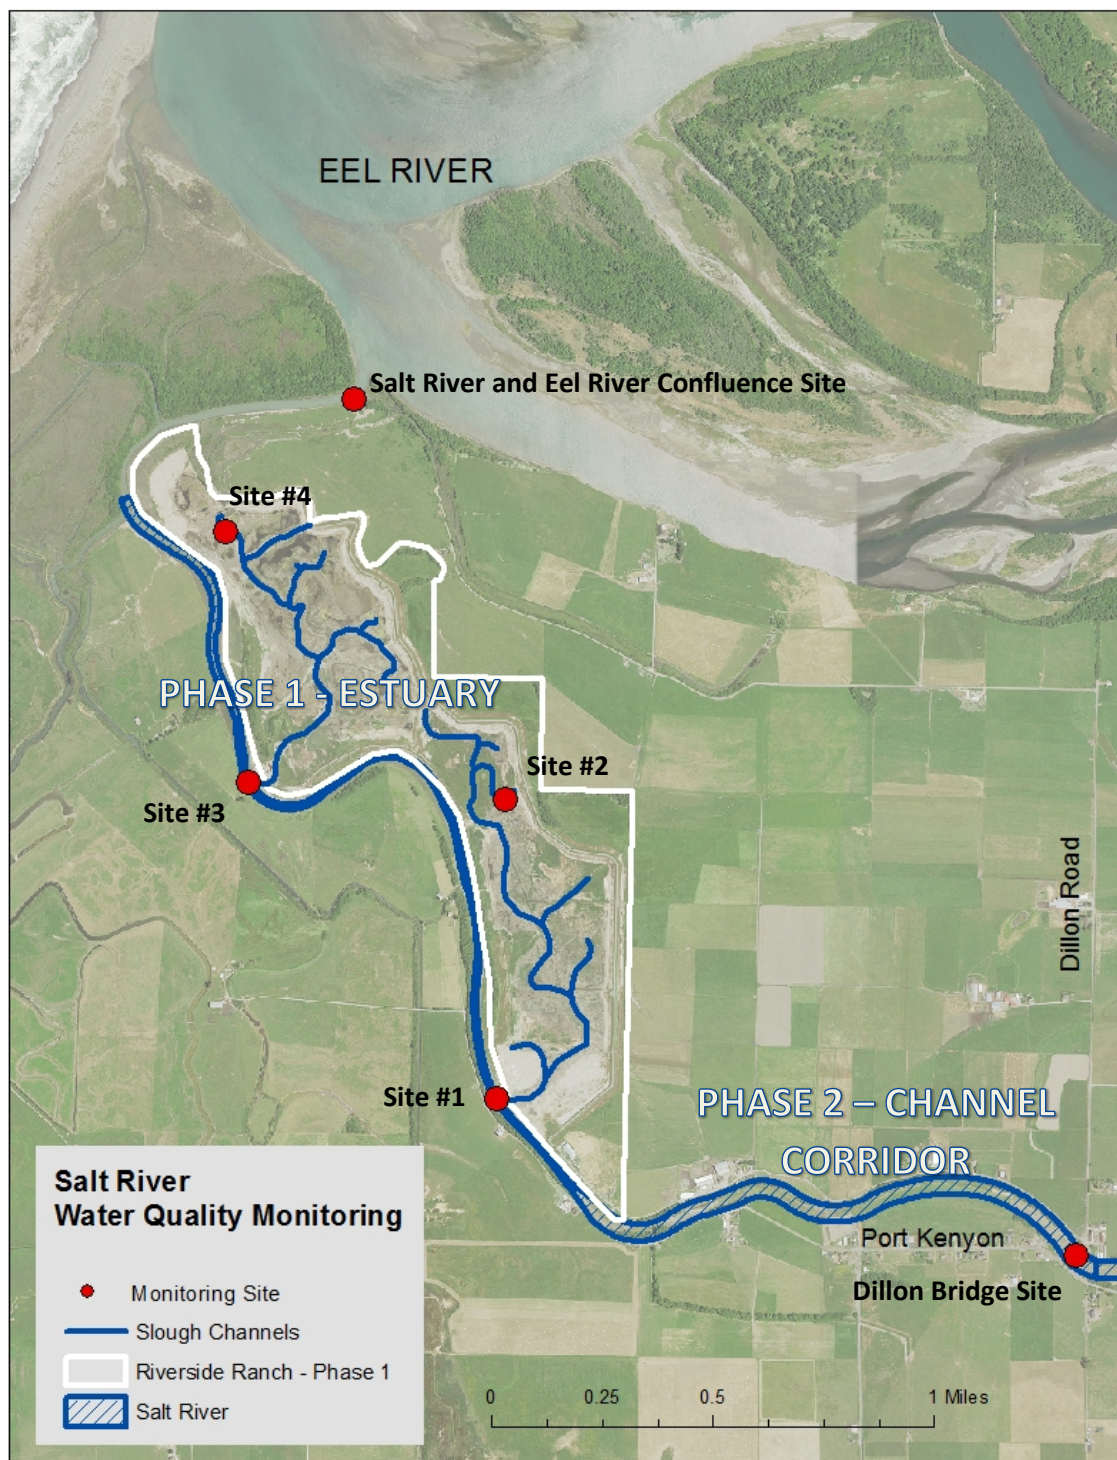
**Figure 1: 2016 Water Quality Sampling Sites across the Salt River Ecosystem Restoration Project.**

- 1) in the Salt River immediately downstream of the confluence of the southern slough channel;
- 2) in the interior of the southern slough channel network.
- 3) in the Salt River immediately downstream of the confluence of the northern slough channel;
- 4) in the interior of the northern slough channel network;
- 5) at the confluence of the Salt River and Eel River

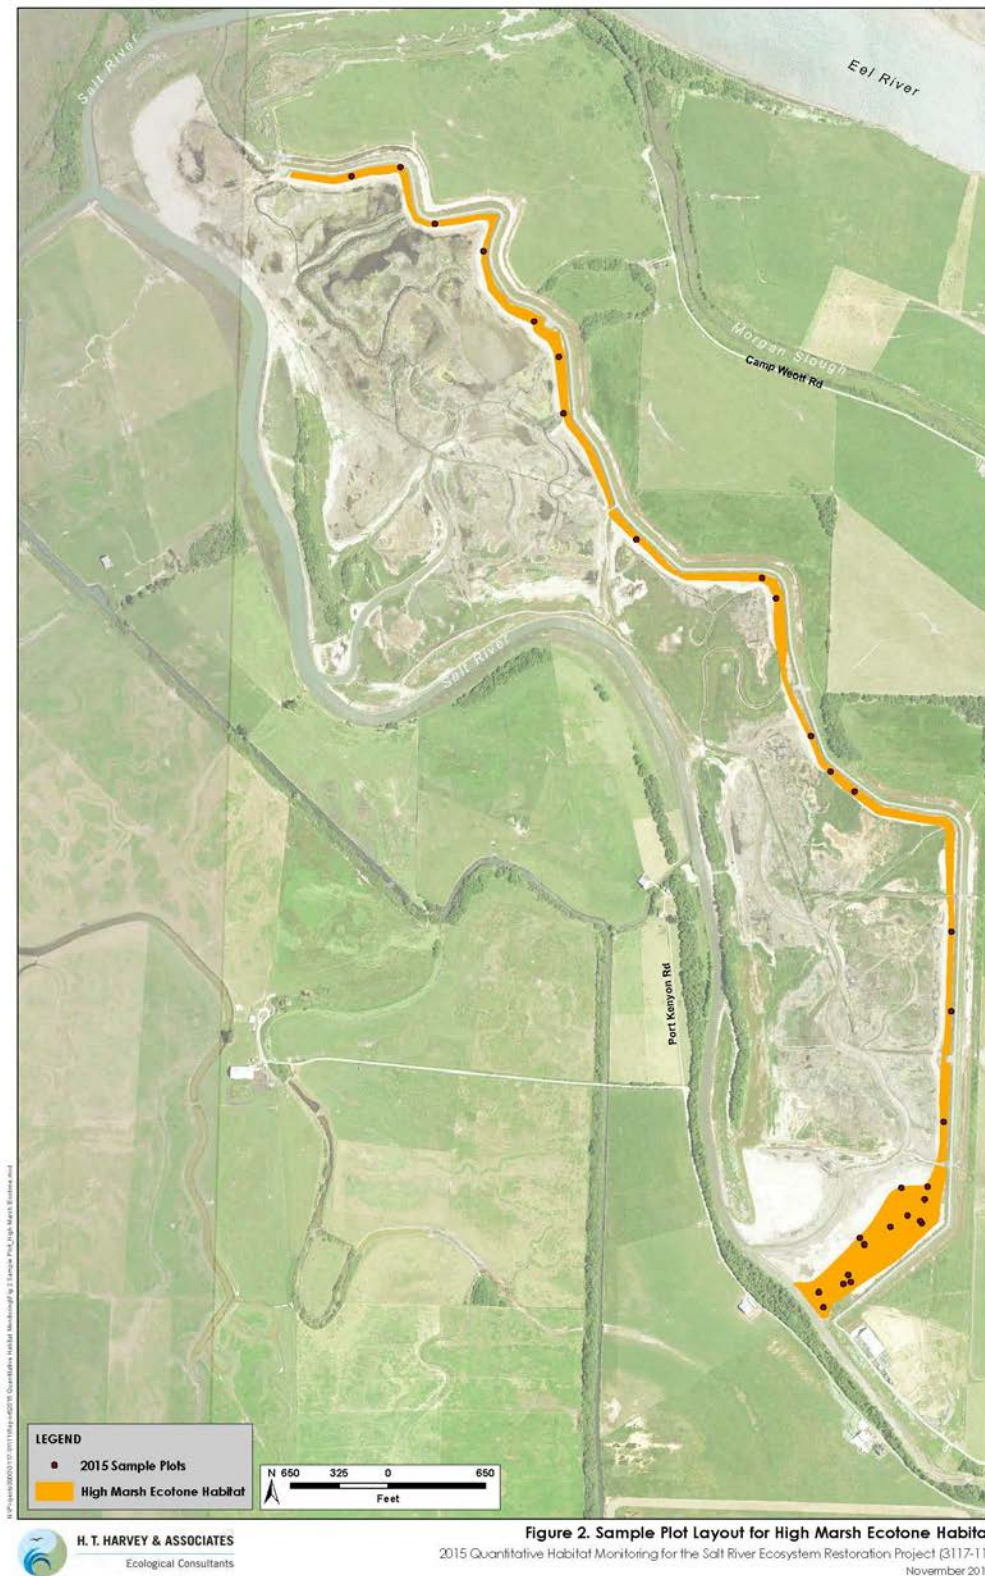
**Figure 2. High Marsh Ecotone Habitat and Sample Plot**

Total vegetation cover in the high marsh ecotone was estimated to be 60.0%, an approximate 14% increase from the total cover of 46.5% estimated in 2014 (HTH 2014). This exceeds the needed 15% success criteria for Year 2. As in 2014, the most common species were two native grasses: tufted hairgrass and meadow barley (*Hordeum brachyantherum*), both found in nearly 80% of the plots. Tufted hairgrass showed a dramatic increase in mean cover, from 9.4% to 27.0%, whereas meadow barley declined from 9.7% to 4.0%. The native salt marsh species perennial pickleweed was found in 50.0% of the plots with a mean cover of 5.6%, a slight increase compared with last year. Salt marsh sand spurry (*Spergularia marina*) also was found in nearly half the plots, with a mean cover of 3.0%. Other native salt marsh species that were present with low cover (<1.0%) included saltgrass and gumplant (*Grindelia stricta*). Fat-hen (*Atriplex prostrata*), a non-native species that colonizes open areas in salt marshes, remained frequent (60.0% frequency), but mean cover dropped from 16.2% in 2014 to 3.9% in 2015, whereas the mean cover of another non-native colonizer, brass buttons (*Cotula coronopifolia*), increased from 0.9% to 11.7%, with 63.3% frequency. The sterile hybrid wheatgrass planted in the high marsh ecotone in fall 2013 to help provide erosion control through the 2014 growing season did not reproduce and thus was not present this year.

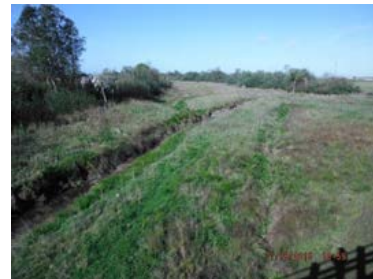
PP109 – Dillon Br W – Nov 2015

Multiple mild winters have helped the project's channel and vegetation stabilize over the initial years. Though several large rain events have tested the project design and observations during storm events have shown that the channel corridor and estuary are functioning as expected.
