Baker Creek Improvement Project

Monitoring Report to NOAA Fisheries

Year 1 Project Summary

Mattole River Watershed
BLM Arcata Field Office

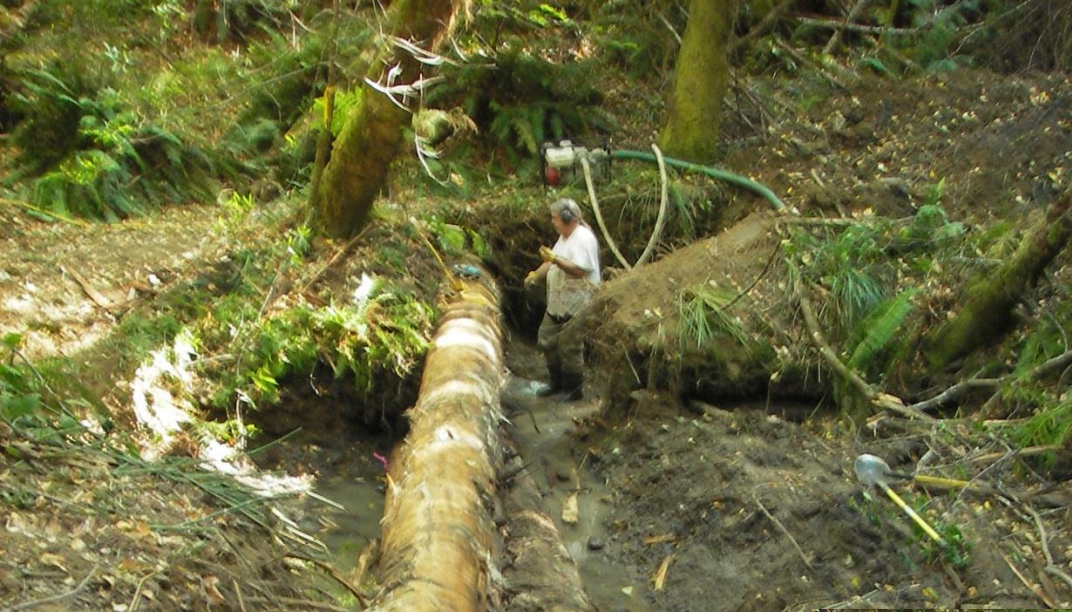
Implementation at step #3. Logs are trenched, anchored to boulders, backfilled and compacted. Trenches are partially filled with boulders anticipating some degree of restored floodplain flow. Logs are installed at target elevations to maintain jump heights and heights relative to the historic floodplain. The three primary grade control log structures are visible in lower photo with step #3 in foreground.

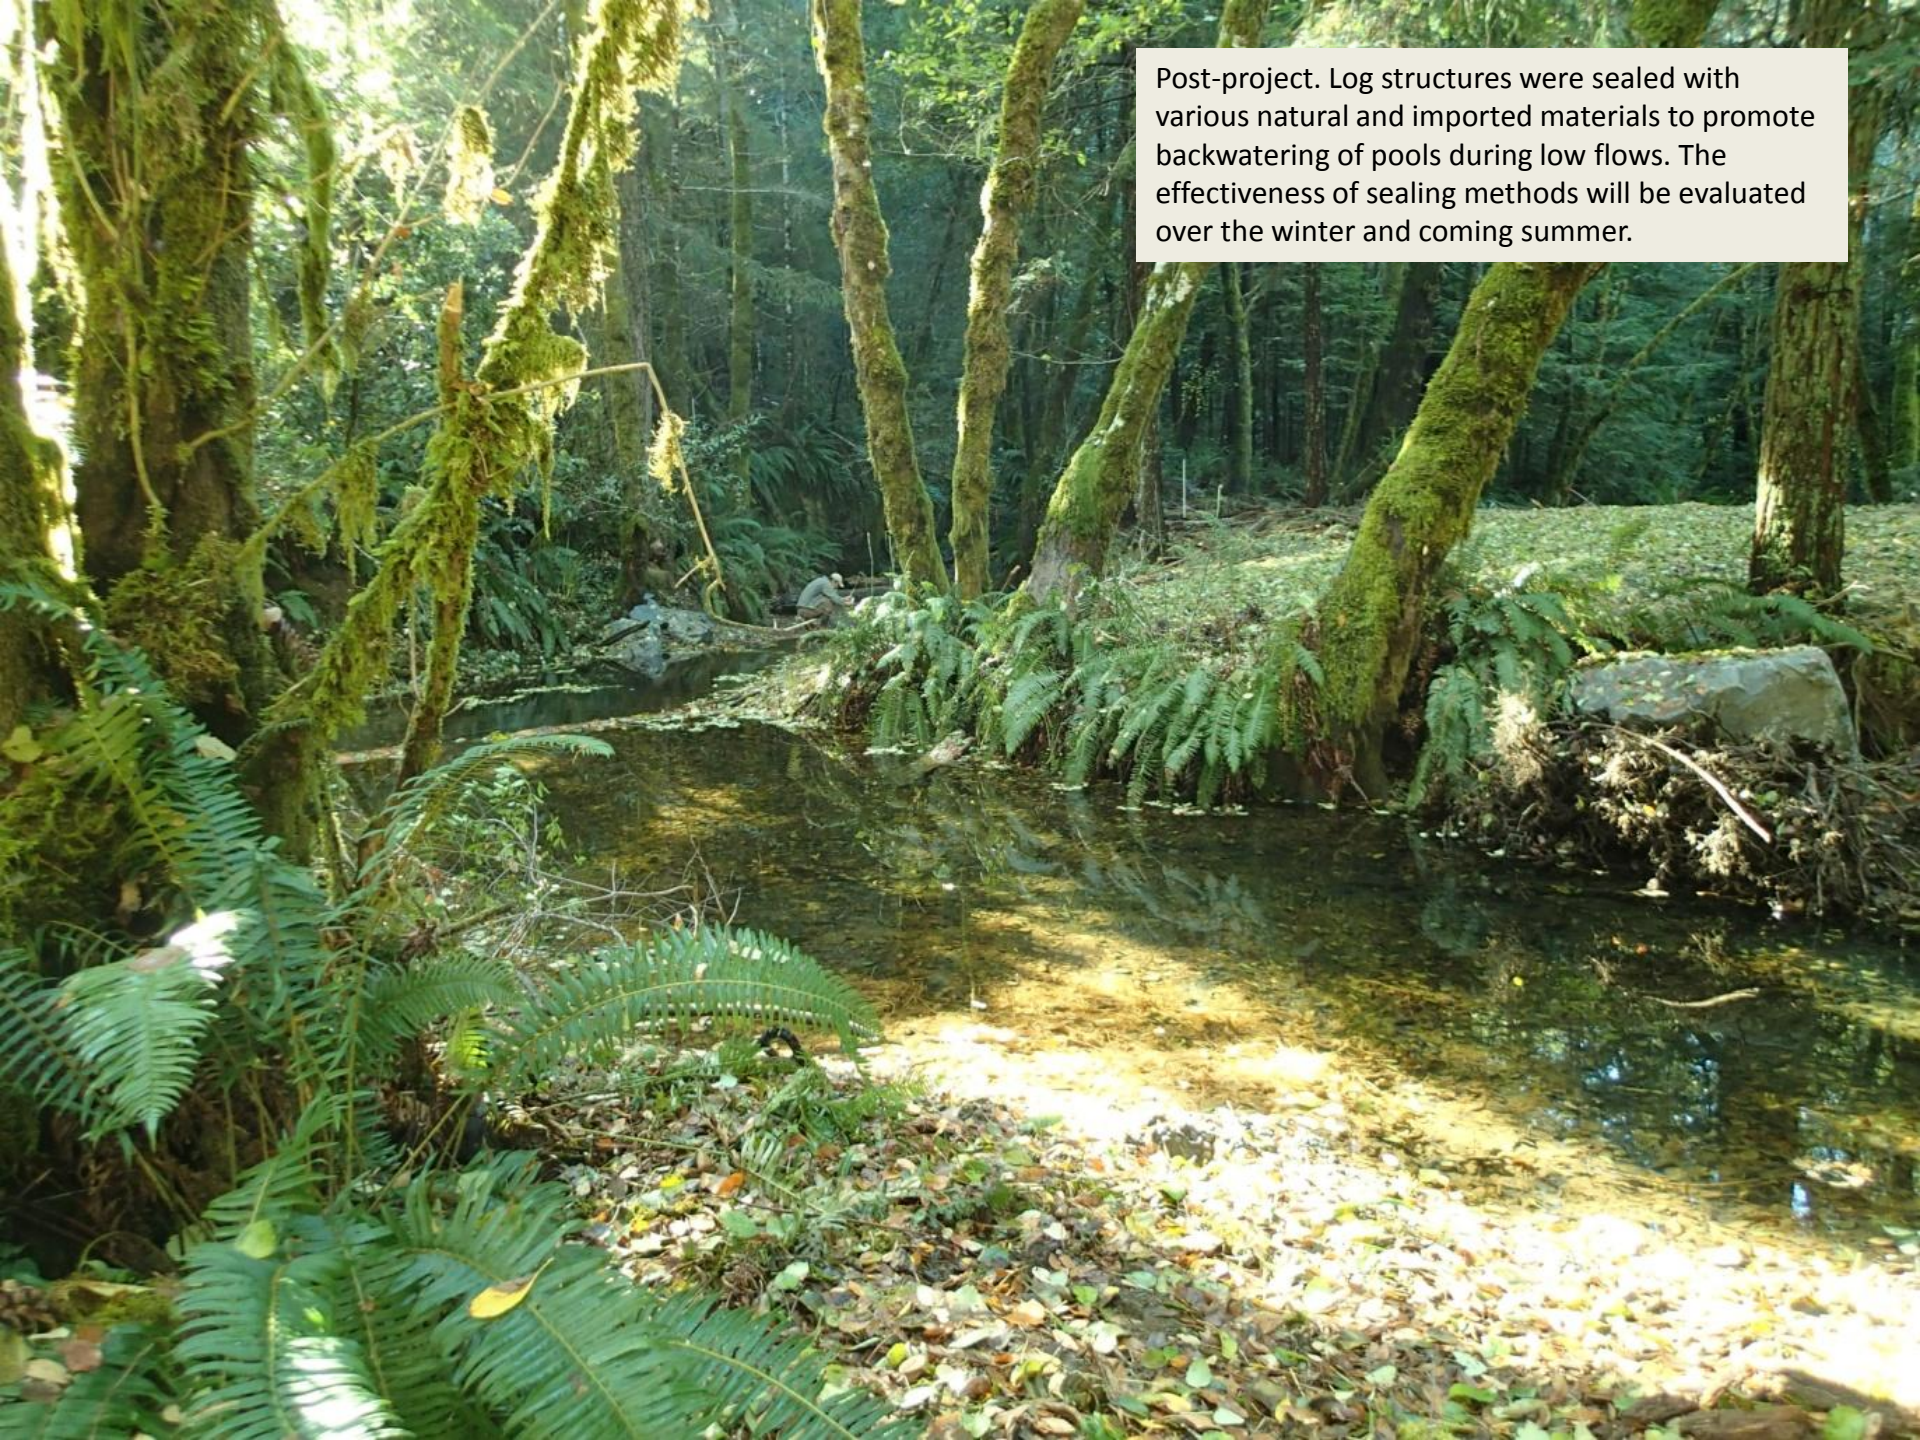
Post-project. Log structures were sealed with various natural and imported materials to promote backwatering of pools during low flows. The effectiveness of sealing methods will be evaluated over the winter and coming summer.

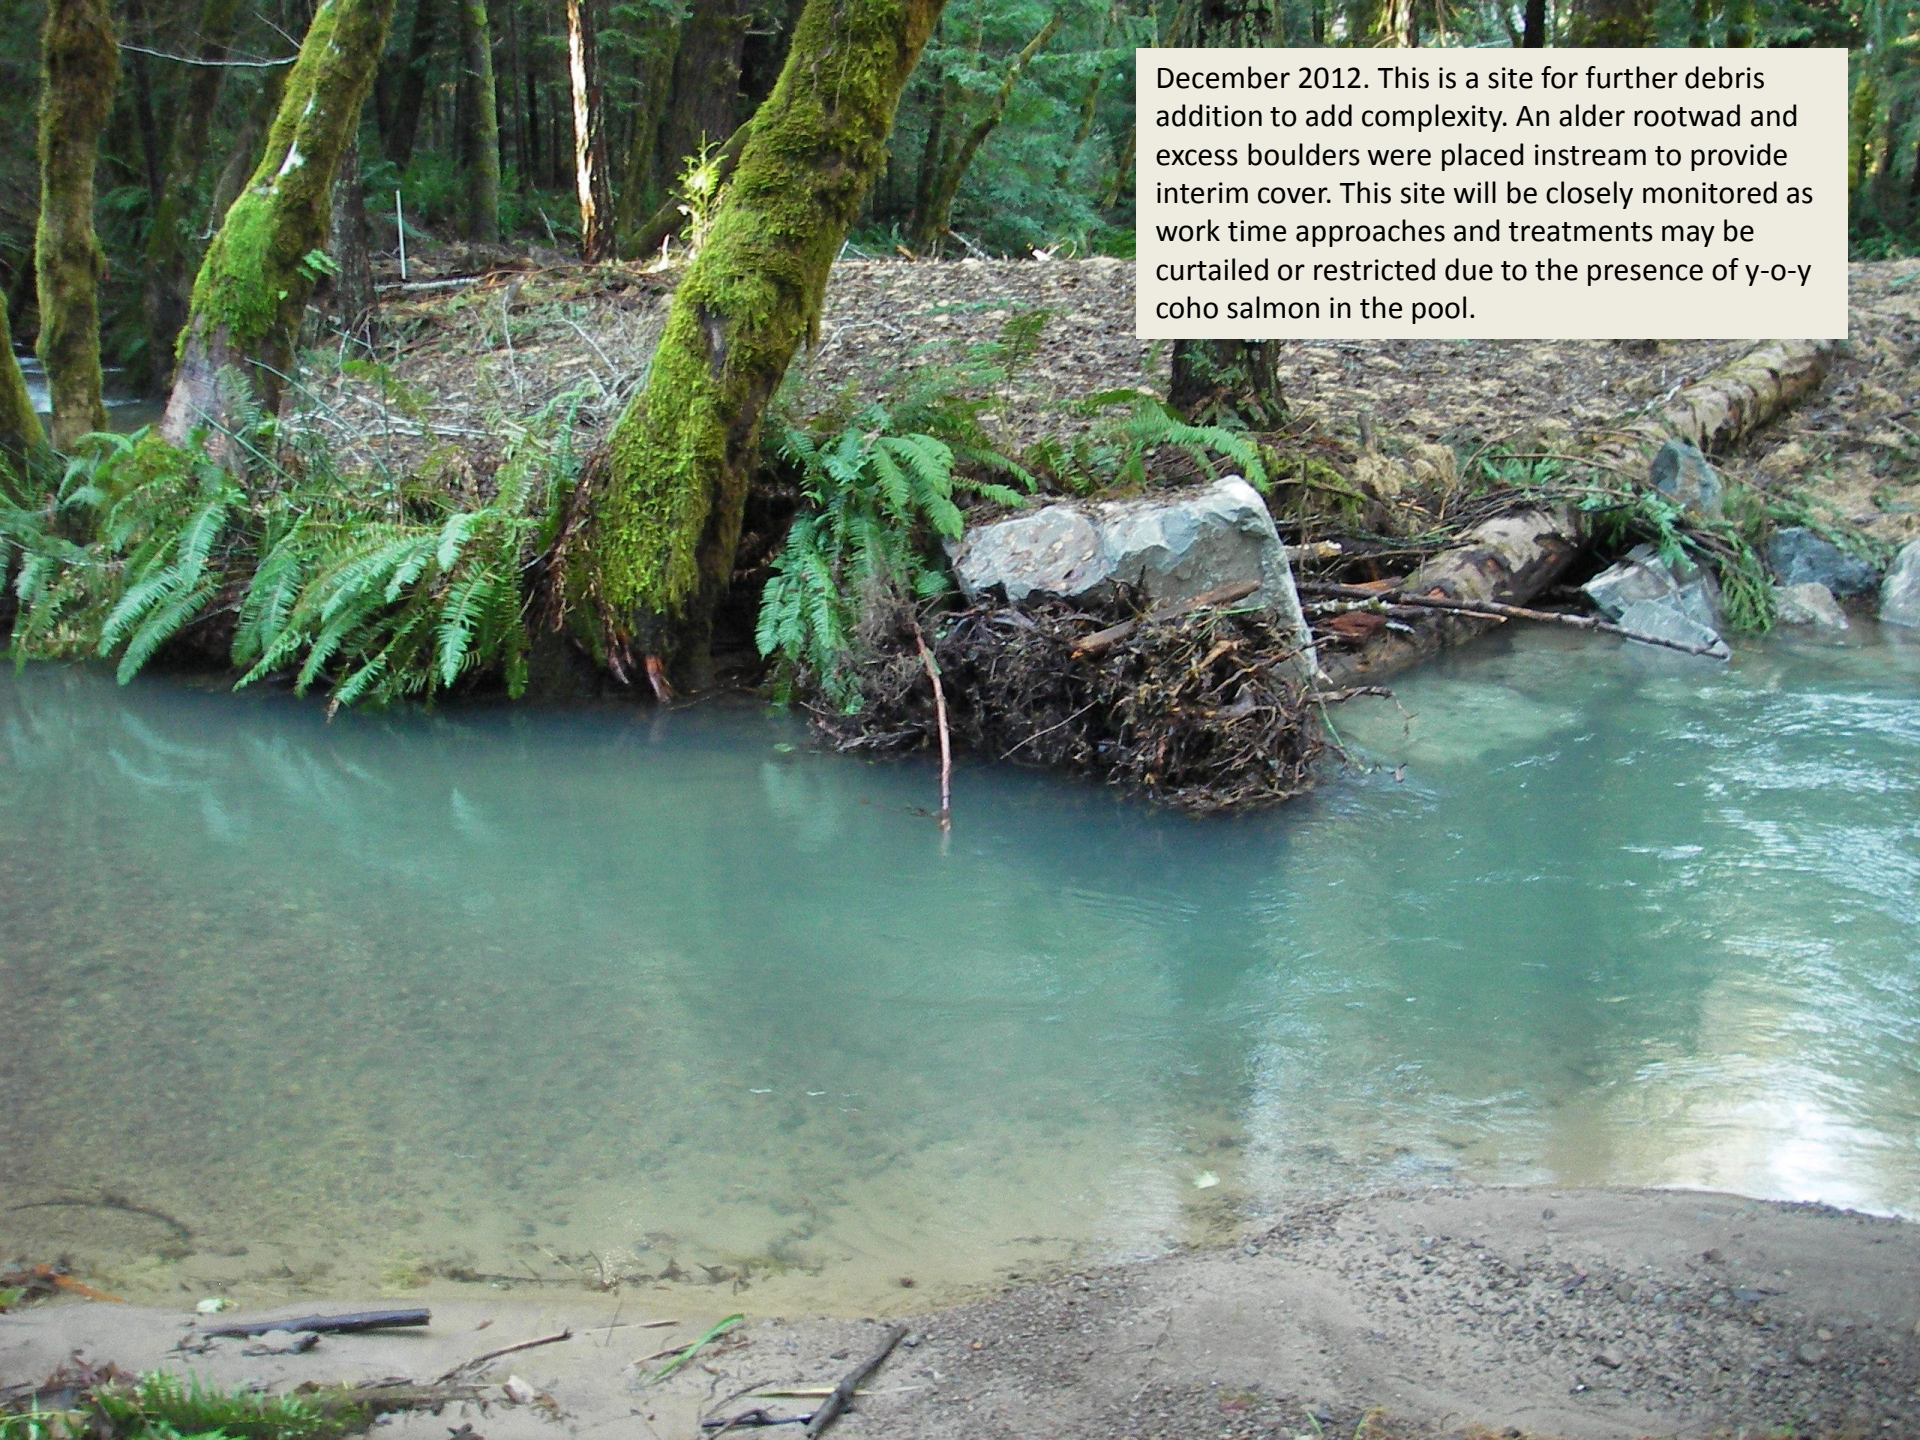
December 2012. This is a site for further debris addition to add complexity. An alder rootwad and excess boulders were placed instream to provide interim cover. This site will be closely monitored as work time approaches and treatments may be curtailed or restricted due to the presence of y-o-y coho salmon in the pool.
